## The impact of modernization of a 16th century timber-framed farmhouse, Suffolk, UK

**Abstract** – *Well intentioned modifications to traditional buildings can potentially be detrimental if the full implications of the work are not fully understood. This paper presents the case of a 16th century Suffolk farmhouse. Extended in the 1700s, the timber-framed building was clad in cement render in the early 20th century. At a later date the timber sole plates were encased in concrete and painted with an impervious resin. Finally in 2005 the panel infills were replaced with rigid polyisocyanurate (PIR) thermal insulation. In-situ environmental monitoring and digital simulation are used to assess the impact of these measures on the performance of the building. The outcomes of this research are now being used to enhance the informed conservation of this building.*

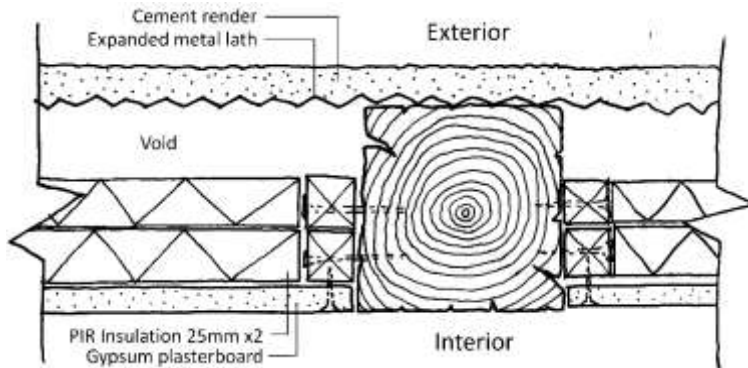
*Figure 4. Sketch plan detail of replacement panel infill at case study. Source: (Author's own, 2017)*

rigid polyisocyanurate (PIR) thermal insulation (Figure 4). In this detail, the cold-bridging of the historic timber-frame is exacerbated by the introduction of additional timber battening to take the plasterboard. The PIR insulation is not mechanically fixed or bonded and is left free-standing within the opening with large gaps around the sides in many instances.

The current owner proposes to remove all external cement render, PIR thermal insulation and gypsum plasterboard infill. The timber-frame will then be fully assessed and any necessary repairs will be undertaken. The house will be re-rendered in lime render on split oak lath, however some uncertainty over the preferred insulation material remains.

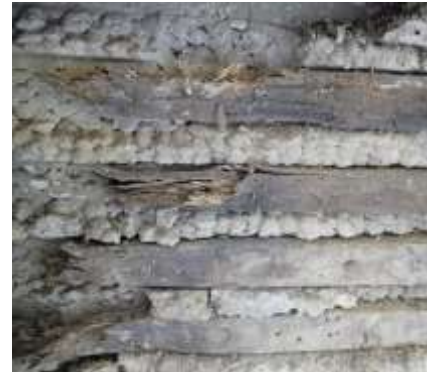
*Figure 5. Internal face of cement render. Source: (Author's own, 2017)*

On opening up the walls, it can be seen that the expanded metal lath used to carry the cement render has in many places completely corroded away and the original oak laths are also in a state of advanced decay (Figure 5). There are also areas where the external cement render is cracked allowing rain penetration into the wall and building interior.

It is likely that the cement render was applied to reduce the need for maintenance of the previous lime render and the PIR insulation installed to improve internal comfort conditions and reduce energy consumption. Both actions were presumably undertaken believing that they were improvements; however, neither have been undertaken with a full understanding of the performance of the historic built fabric, and have now resulted in the poor current condition of the building. Today many of the timbers are rotten and will require replacing and the cement render is in danger of collapse.

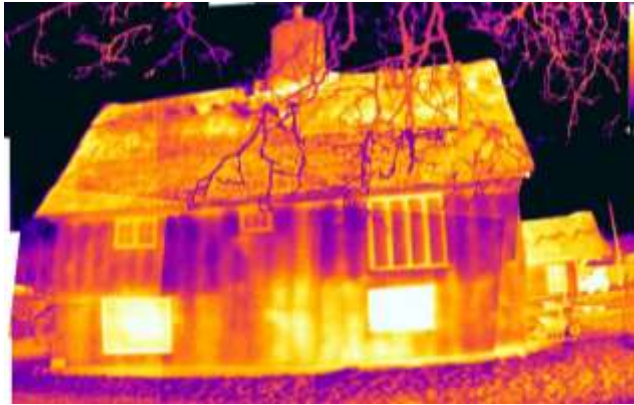
Figure 6. External thermography of east façade. Source: (Author's own, 2017)

Figure 6 shows the higher internal temperatures of the ground floor, especially the study (bottom-right) where a 10°C temperature differential was achieved. The single glazed windows of the study and master bedroom are the weakest thermal element of this façade. The concrete encased brick plinth is shown to be a thermal bridge, as is the close studded timber frame which is clearly visible through the cement render.

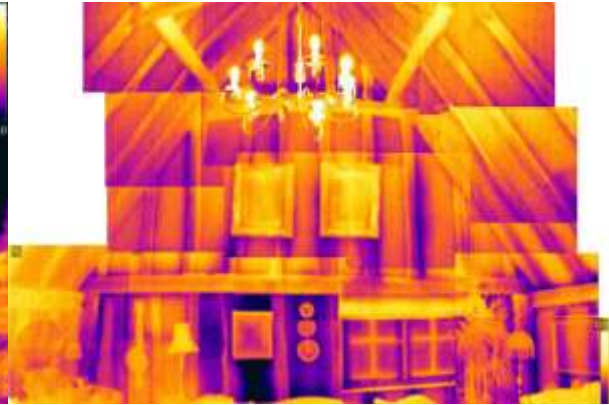
Figure 7. Interior thermography of north wall of drawing room. Source: (Author's own, 2017)

The internal thermography (Figure 7) confirms the previously noted weakness of the junction between the modern PIR thermal insulation and the timber-frame. This detail has no sealant or taping and as such, thermal transfer through air movement is occurring. The low radiant surface temperature of the infill panel to the bottom centre left of the image is however unexplained and requires further exploration.

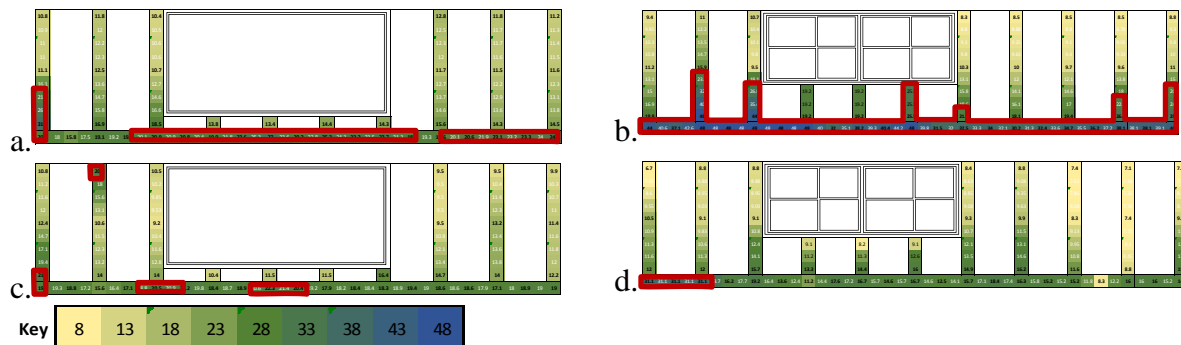
Figure 8. Surface moisture content (%) of timber-frame. Ground floor. Bedroom east wall (a.02/08/2016 and c.11/03/2017) Study north wall, (b.02/08/2016 and d.11/03/2017). Source: (Author's own, 2017)

Figure 8 shows high moisture content in the sill beam of both walls due to their encasement in cement rendered brick externally and resin coated internally. Evidence of drying can be seen between the summer (upper) and winter (lower) measurements.

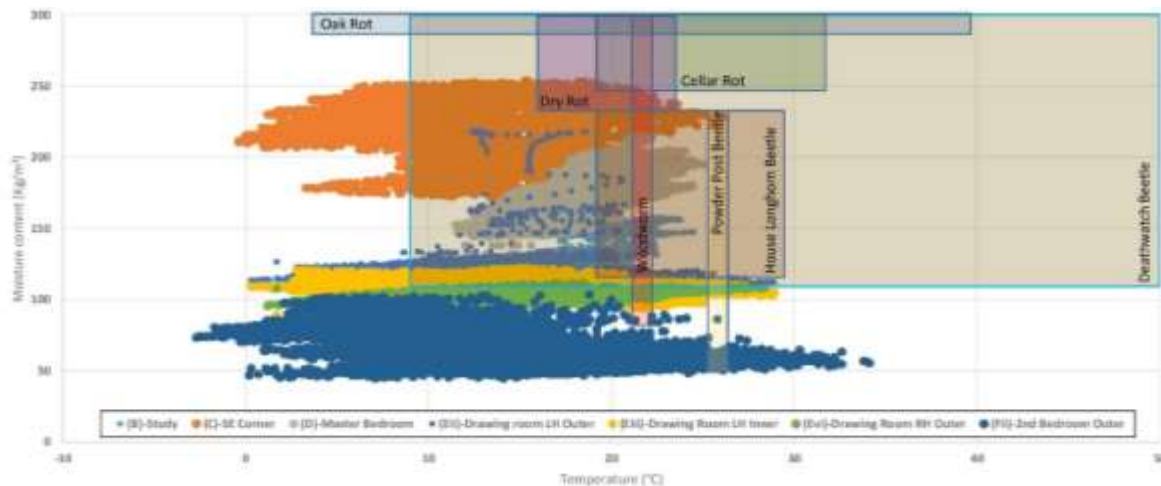
**Figure 9. Hygrothermal conditions at monitoring positions with conditions favourable to biological attack overlaid. Source: (Author's own 2017, with conditions favourable to biological attack based on [15])**

The results indicate that many of the monitoring locations are experiencing hygrothermal conditions favourable to biological attack (Figure 9). The most frequent risk is from deathwatch beetle, with the sill beam in the SE corner of the master bedroom being open to this threat 99% of the time. This location is also at threat from house longhorn beetle more than 1000 hours per year. Within the same wall there also exists 249 hours when conditions are favourable for dry rot and 35 hours favourable to cellar rot. This further increases the risk of insect attack as both deathwatch and house longhorn will only inhabit wood previously damaged by decay. An instance of penetrating damp due to wind driven rain was recorded, with the affected area taking 9 months to return to its previous moisture levels.
