Energy Retrofit of Historic Timber-Frame Buildings- Hygrothermal Monitoring of Building Fabric

C. J. Whitman, O. Prizeman, J. Gwilliam

Welsh School of Architecture, Cardiff University, Cardiff, UK

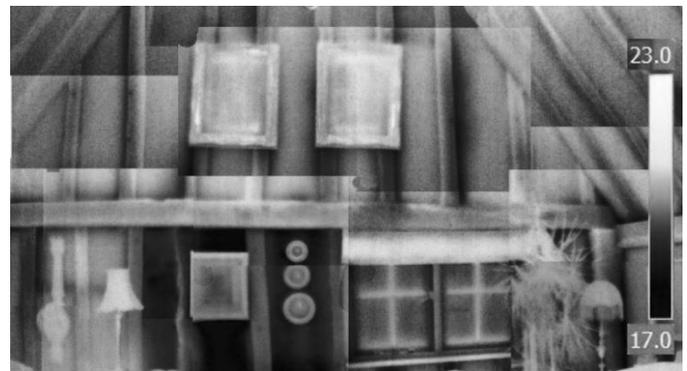
At one case study the replacement infill detail achieved only 53% of the calculated U-value. Thermographic surveys (Figure 1) highlight the lack of hermeticity between infill and timber-frame, leading to a high air change rate and associated increased heat loss. This was confirmed through pressure testing, with an air permeability index of 19 m³/h/m².

Figure 1. Thermographic image of interior of case study 5, showing poor connection between infill and timber-frame.

Measurements of timber moisture content and temperature at the same case study showed that the use of non-vapour permeable materials, in conjunction with the poor detailing, had led to the creation of hygrothermal conditions that would facilitate biological attack [13]. In another case study, measurements pre and post-retrofit showed an increase in timber moisture content due to the lack of controlled ventilation.
