Large Scale Application of Self-Healing Concrete: Design, Construction, and Testing

Materials for Life (M4L) was a 3 year, EPSRC funded, research project carried out by the Universities of Cardiff, Bath and Cambridge to investigate the development of self-healing cementitious construction materials. This paper describes the UK's first site trial of self-healing concrete, which was the culmination of that project. The trial comprised the *in-situ* construction of five concrete panels using a range of self-healing technologies within the site compound of the A465 Heads of the Valleys Highway upgrading project. Four self-healing techniques were used both individually and in combination with one another. They were: (i) the use of microcapsules developed by the University of Cambridge, in collaboration with industry, containing mineral healing agents, (ii) bacterial healing using the expertise developed at Bath University, (iii) the use of a shape memory polymer (SMP) based system for crack closure and (iv) the delivery of a mineral healing agent through a vascular flow network. Both of the latter, (iii) and (iv), were the product of research undertaken at Cardiff University. This pape

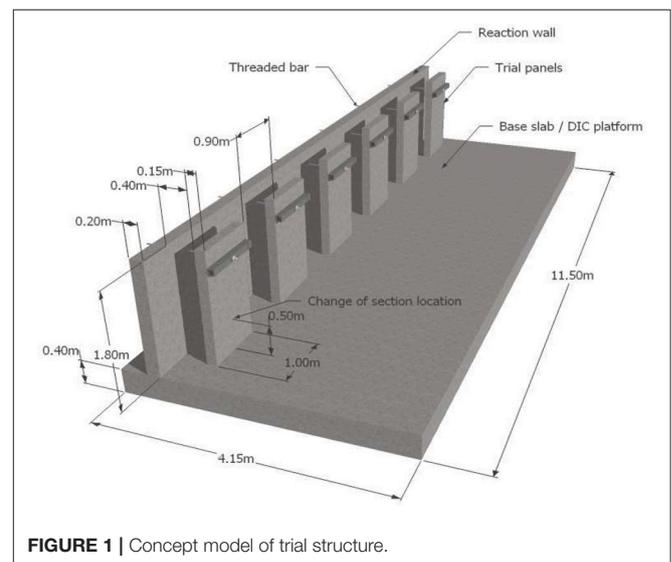
FIGURE 1 | Concept model of trial structure.

The A465 HoV project includes long lengths of retaining walls of varying height and design and so the trial comprised multiple sections of mock retaining walls, referred to as panels, which were designed to contain different combinations of the self-healing techniques that have been developed. Two panels that did not contain any self-healing mechanisms were also constructed to act as the controls. The overall structure included a reaction wall for loading the trial panels, as well as a base slab to prevent overturning of the walls during loading. A concept model of the structure is shown in **Figure 1**. For all elements of this structure, the detailed structural design was completed according to the provisions of BS EN 1992. The panels were designed to crack at 500 mm above the base slab by including 16 mm diameter starter bars at 200 mm centers on the front face up to this point, before changing to an A393 mesh (10 mm diameter bars @ 200 mm centers) to create a weak section in the panel at this change of steel section location (Teall, 2016). The nominal cover to the A393 mesh was 30 mm and the rear face was reinforced with an A142 steel mesh (6 mm diameter bars @ 200 mm centers) with a nominal cover of 20 mm.

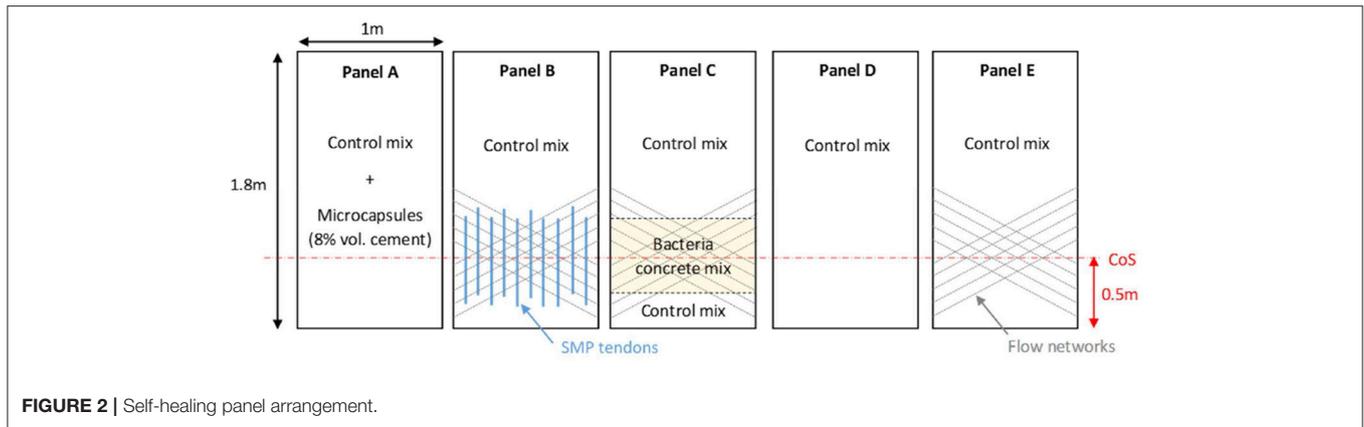
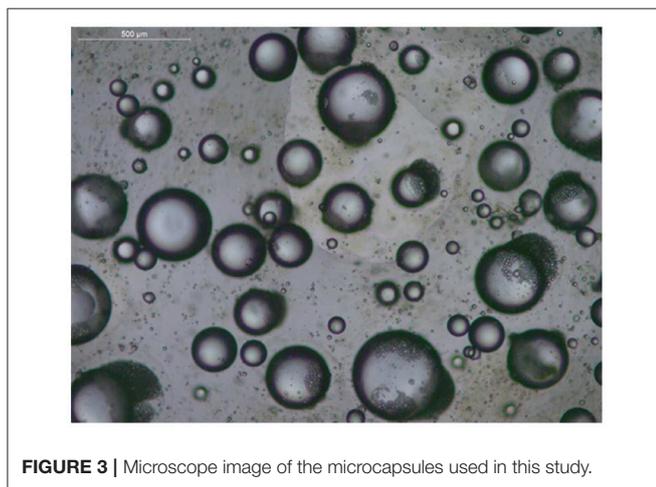
Each panel on the trial structure was used to test a particular self-healing technique or combination of techniques. These techniques are detailed in **Table 2** and their setup is shown schematically in **Figure 2**.

Spherical, polymeric microcapsules, carrying a sodium silicate emulsion, were used in Panel A. Sodium silicate was selected as the healing compound, as it forms products of a similar nature to the host cementitious matrix. The potential of sodium silicate as a healing agent for cement-based composites was previously investigated, both in terms of crack closure and durability, by Kanellopoulos et al. (2015); Giannaros et al. (2016), who confirmed its compatibility in cementitious matrices. The microcapsules had a polymeric shell made of cross-linked gelatin and acacia gum giving a wall thickness ranging from 5 to 20 μm . Their cargo was an emulsion of sodium silicate in mineral oil (54% Mineral Oil, 42% Sodium Silicate, 4% Emulsifier by weight). The size of the microcapsules ranged from 300 to 700 μm and they had a density of $\sim 1.0 \text{ gr/cm}^3$. **Figure 3** shows an optical microscope image of the microcapsules.

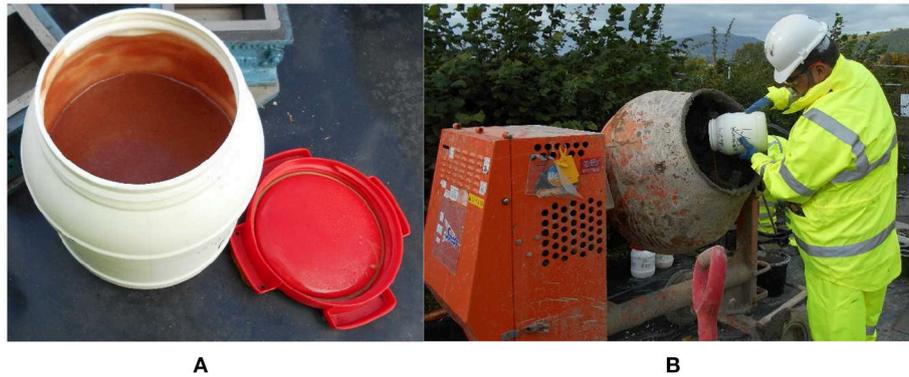
FIGURE 4 | (A) Microcapsules in solution prior to mixing and **(B)** addition of microcapsules into the mix.

A total of 8% by volume of cement of microcapsules were mixed into the concrete using the onsite Belle mixer. As the microcapsules were provided by Lambson in a preserving aqueous solution, this added an additional small quantity of water to the concrete mix, increasing its water-cement ratio from 0.43 to 0.45. This had a minimal effect on the slump increasing it by $< 20 \text{ mm}$. **Figure 4** shows the microcapsules in solution prior to and during their addition to the mix.

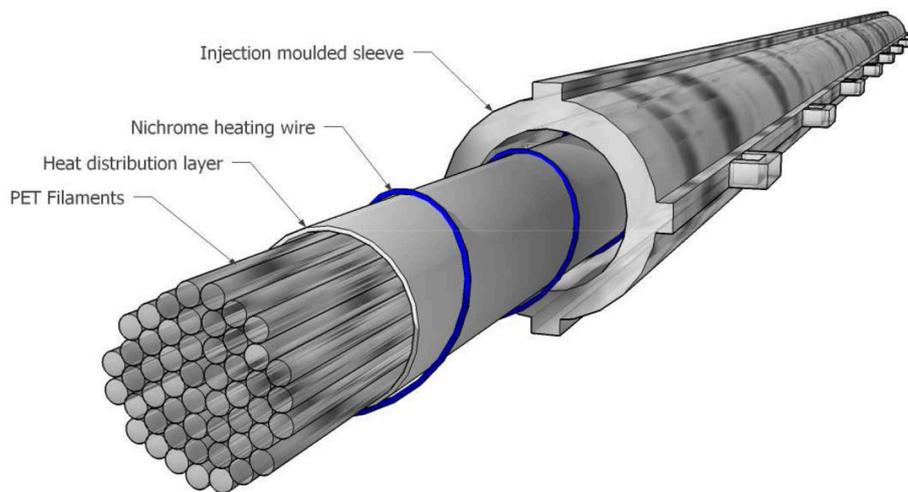
FIGURE 5 | Shape memory PET tendon crack closure system (Teall et al., 2018).

Ten SMP tendon units were placed in the panel, which were designed, upon activation, to generate a stress of 0.5 MPa across the cracked external face. Each tendon contained 200 PET filaments, surrounded by a heating system and injection molded sleeves, as shown in **Figure 5**. The PET filaments were manufactured by Bradford University specifically for this project, and were found to be capable of generating a restrained shrinkage stress of 30 MPa in the laboratory. These tendons were 750 mm in length and placed at an eccentricity of 40 mm from the center of the panel's cross-section in a staggered layout, as shown in **Figures 6, 7**.

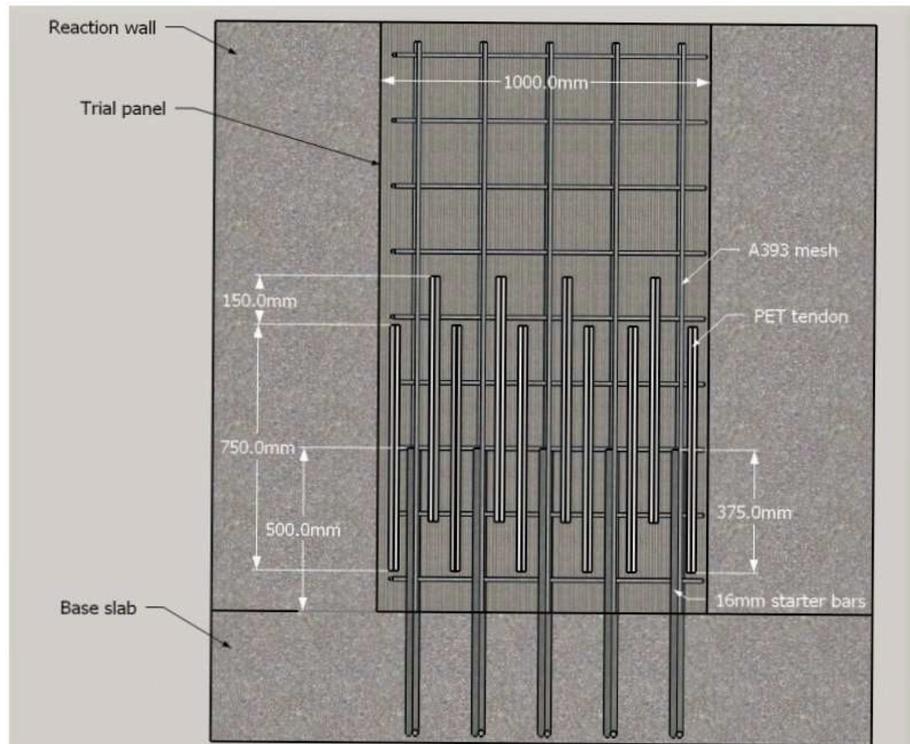
FIGURE 6 | Position of SMP tendons within Panel B.

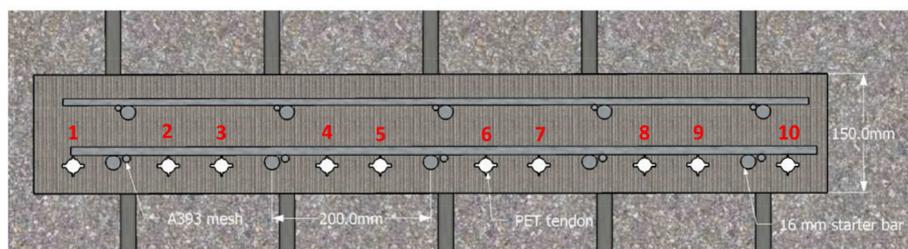
FIGURE 7 | Cross-section of Panel B layout with PET tendons.

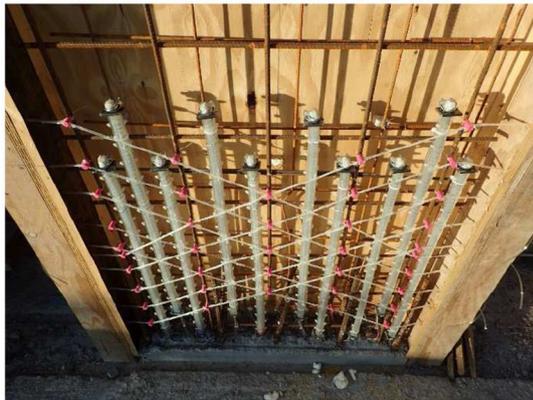
FIGURE 8 | Layout of SMP tendons and flow networks in Panel B.

Flow networks were included in Panel B to allow the introduction of healing agents into the concrete. A 2D network of 4 mm diameter channels was created using polyurethane tubes, which were removed from the concrete after the formwork had been struck. The channels were connected using 3D printed joints made from polylactic acid (PLA), which were tied to the outermost reinforcement, allowing the networks to pass in front of the SMP tendons. At either side of the panel, the flow networks were terminated with lockable steel injection packers, which allowed each channel to be sealed individually to aid the loading and pressurizing of the network. The final layout of the tendons and flow networks within the panel prior to casting is shown in **Figure 8**.

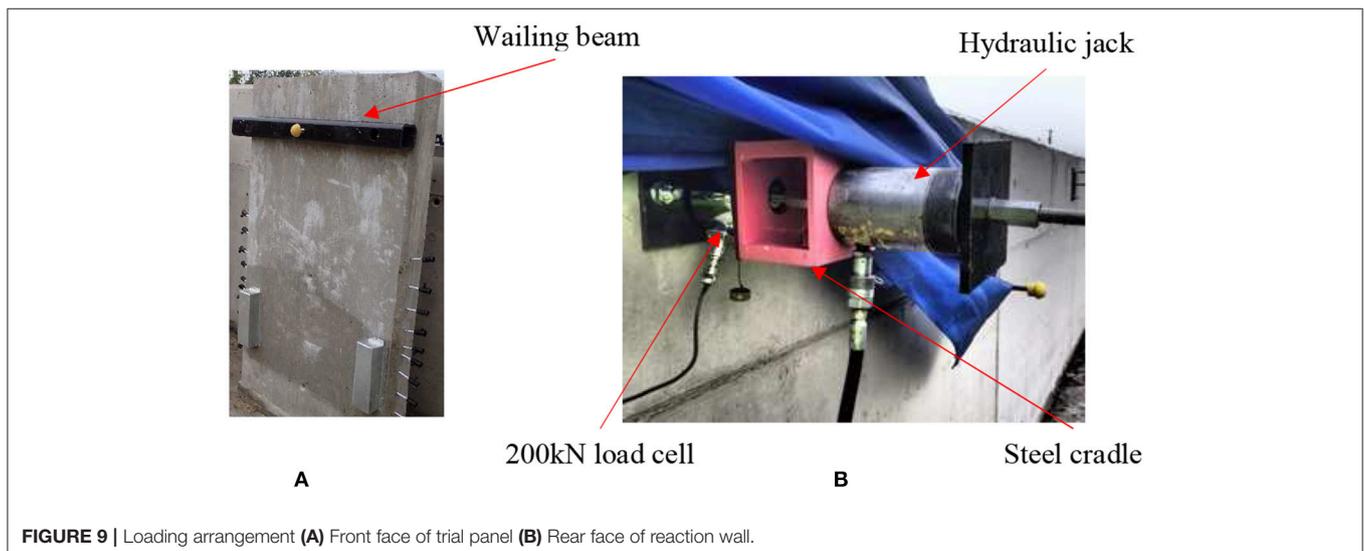
FIGURE 9 | Loading arrangement (A) Front face of trial panel (B) Rear face of reaction wall.

The cracks that were to be investigated for healing were created by damaging the panels using controlled loading. A threaded bar and a hollow ram hydraulic jack system was adopted to apply the load. This system had a bar running through the center each panel and reaction wall at 1.5 m above the base slab. The loading was distributed across the full width of the panel using a rectangular hollow steel waling beam, 100 × 100 mm in section and 10 mm in thickness. On the back face of the reaction wall, the threaded bar passed through a load cell and steel cradle to allow the load to be “locked off” once it had been applied. A hollow ram, hydraulic jack connected to a hand pump was then attached to the bar beyond the cradle to enable a load to be applied to the panels. The general arrangement of this loading system is shown in **Figure 9**. The reaction wall was designed to be of sufficient strength and stiffness to allow the loading to damage the panels whilst experiencing minimal damage and displacement itself. In this way, the panels were loaded as cantilever structures and the fractures appeared on their “front” faces to allow easy monitoring over time.

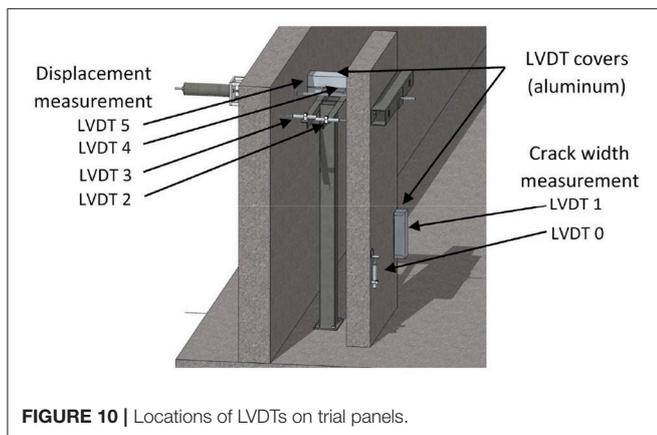
FIGURE 10 | Locations of LVDTs on trial panels.

Six LVDTs were used to monitor each panel and the locations of these are shown in **Figure 10**. The two LVDTs were placed on the front face to monitor cracks opening and four LVDTs were located between each panel and the reaction wall to monitor the displacement of the panel and reaction wall during loading. The LVDTs were attached to a RHS steel column, which was in turn bolted to the base slab using chemical anchor bolts, to provide displacement readings of the panel independent of the reaction

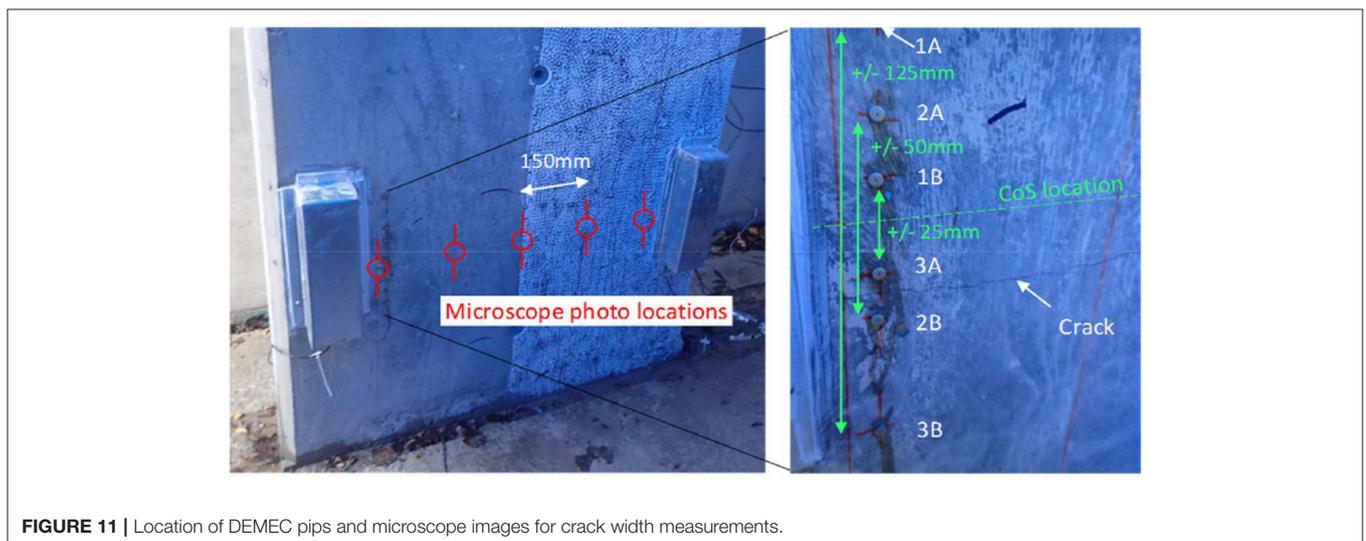
FIGURE 11 | Location of DEMEC pips and microscope images for crack width measurements.

In addition to the LVDTs 3 sets of DEMEC pips, with a gauge length of 100 mm, were placed on the front left and right face of each panel, as shown in **Figure 11**. Five crack width measurements were taken at the change of section (CoS) location across the width of each panel using a hand held microscope. A notched gauge was used as a scale for each image and the crack width was measured perpendicular to the crack direction using ImageJ software (Schneider et al., 2012). Three measurements were made from each image, at approximately equal spacing across the field of view and then averaged to give a single crack width value for that location.

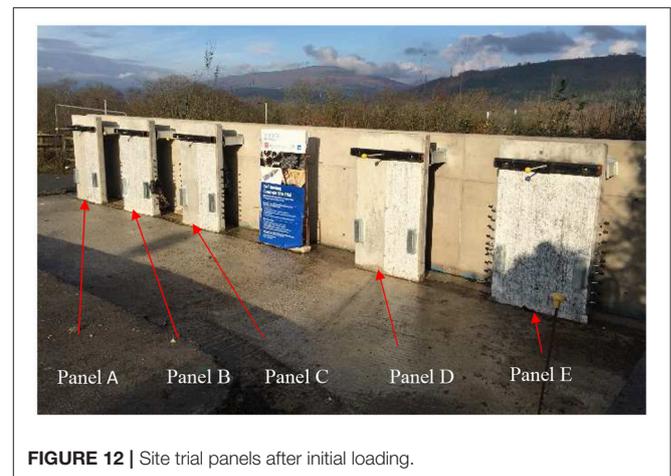
**FIGURE 12** | Site trial panels after initial loading.

be employed in large-scale applications and this was successfully achieved as evidenced in **Figure 12**. Although it was originally intended to cast six panels, the central panel wasn't used, being kept as a reserve in case of unforeseen problems during construction. The following sections describe some of the many valuable lessons learnt from the construction of these panels.

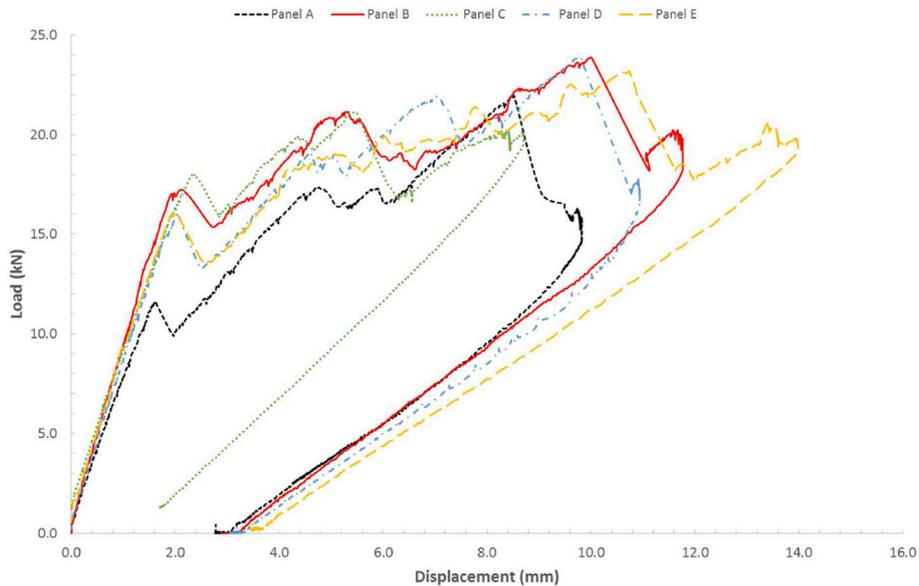
FIGURE 13 | Load-displacement curves for all panels during the initial loading stage.

The load/displacement curves for all panels during the initial loading stage are presented in **Figure 13**. This comparison explores the differences in the stiffness and flexural strength of the panels. The displacement values were obtained from LVDTs 2 and 4 positioned at the level of the loading bar (**Figure 10**) and measured the displacement of the panel relative to the mounting column. For the purposes of comparing overall displacement, the average value of the two transducers was used, taking account of any twisting in the panels.

The load-displacement profiles are similar for all panels, but with some key discrepancies. For Panels B, C, D, and E, initial small reductions in load can be observed between 16 and 18 kN and this corresponds to the first cracks at the base of the wall. Fluctuations in load are observed beyond 18 kN with a second significant reduction in load at around 21–22 kN corresponding to a second crack about 200–300 mm above the base. Panel A, containing microcapsules, experienced initial cracking at about 250 ± 20 mm above the base at the much lower load of 11.6 kN, however, this panel did crack at the base of the panel at around 17 kN which is consistent with the other panels. Further load was then applied until a crack formed at the CoS location. Panel C, containing the bacterial concrete layer, experienced cracking at the CoS location with the least amount of deflection and Panel E had the largest deflection at 14.35 mm.

It can also be seen that the gradient of the initial loading curve for Panel B is slightly greater than that of all of the other panels. This indicates that this panel has a greater stiffness, probably due to the contribution of the PET tendons. The loading curve of Panel A has the smallest gradient, indicating that this panel has the lowest stiffness. This could be a result of the inclusion of the polymeric capsules into the mix or the slightly higher water-cement ratio of this concrete compared to the control, and it is consistent with the cube strength results presented in section Concrete Strength.

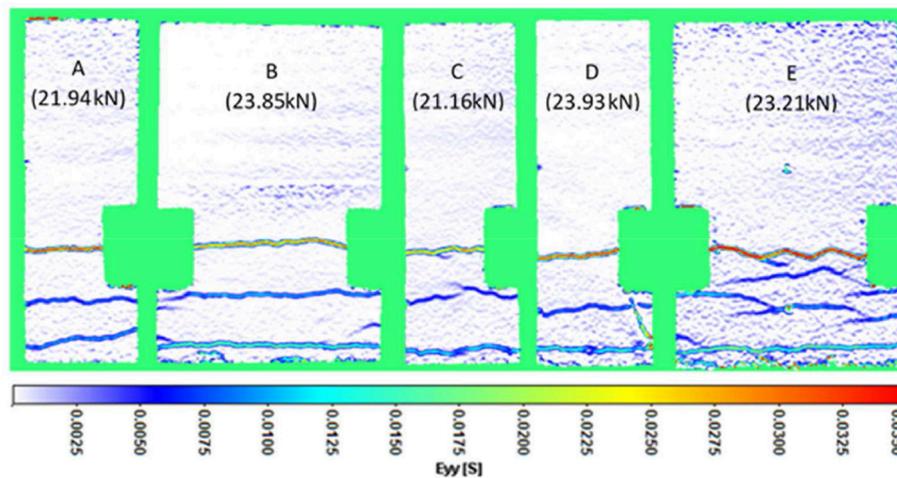
FIGURE 14 | DIC images of all panels at peak load during initial loading.

Figure 14 shows DIC images of all five panels immediately following cracking at the CoS. The loads displayed are indicative

of the peak load immediately before the formation of these cracks. As indicated when discussing the experimental set-up, Panels A, C and D are shown as half-panels, to enable permeability measurements to be taken across the non-painted side of the panels.

The DIC images show some branching of the cracks. This is particularly evident on Panel E, which has flow networks in addition to the control concrete. The presence of these multiple cracks and a larger displacement of the panel at higher loads suggests that there is a loss of strength but an increase in ductility due to the inclusion of the flow networks.

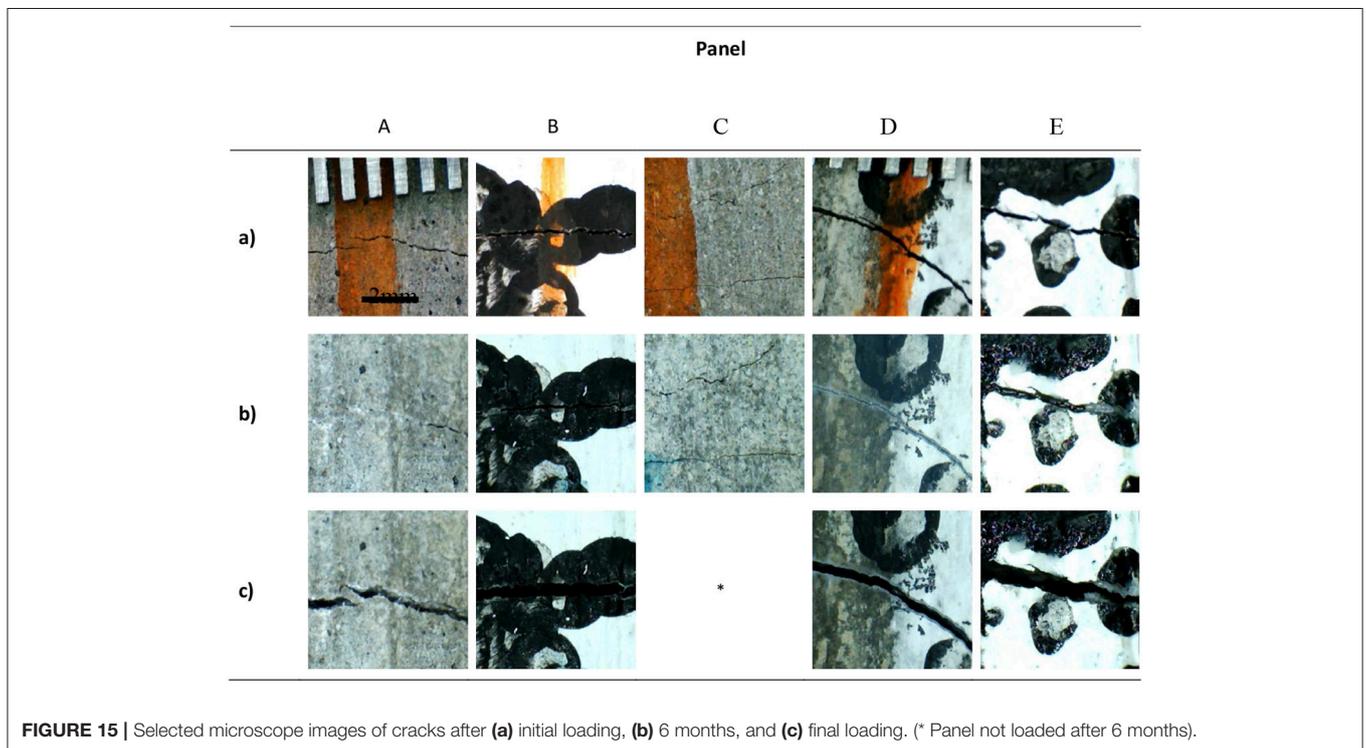
**FIGURE 15** | Selected microscope images of cracks after (a) initial loading, (b) 6 months, and (c) final loading. (* Panel not loaded after 6 months).
