***ACOUSTIC EMISSION ANALYSIS OF
PRESTRESSED CONCRETE STRUCTURES***

PhD Thesis

***School of Engineering
Cardiff University, Cardiff
UK
May 2013***

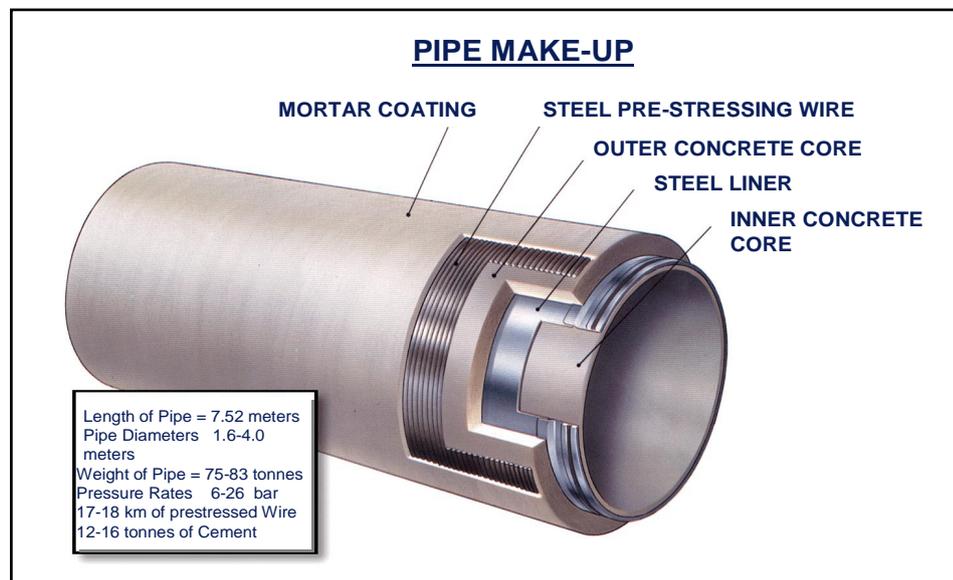
pipe consists of a 225 mm thick concrete core within an embedded thin steel cylinder and externally wrapping prestressed wires. The cured concrete core is prestressed by applying over-wrapping with high tensile steel wire at a close pitch under uniform tension. The prestressed wires are covered by a 19 mm thick layer of cement mortar to protect the wires against corrosion and mechanical harm. This type of pipe is called a ‘white’ pipe and is used in non corrosive soil whilst a ‘black’ pipe is used in more aggressive conditions. In black pipes the cement mortar is coated by a black coal tar epoxy. A typical cross-section of the PCCP is shown in Figure 1.2.

Figure 1. 2 Typical Cross-Section of the PCCP

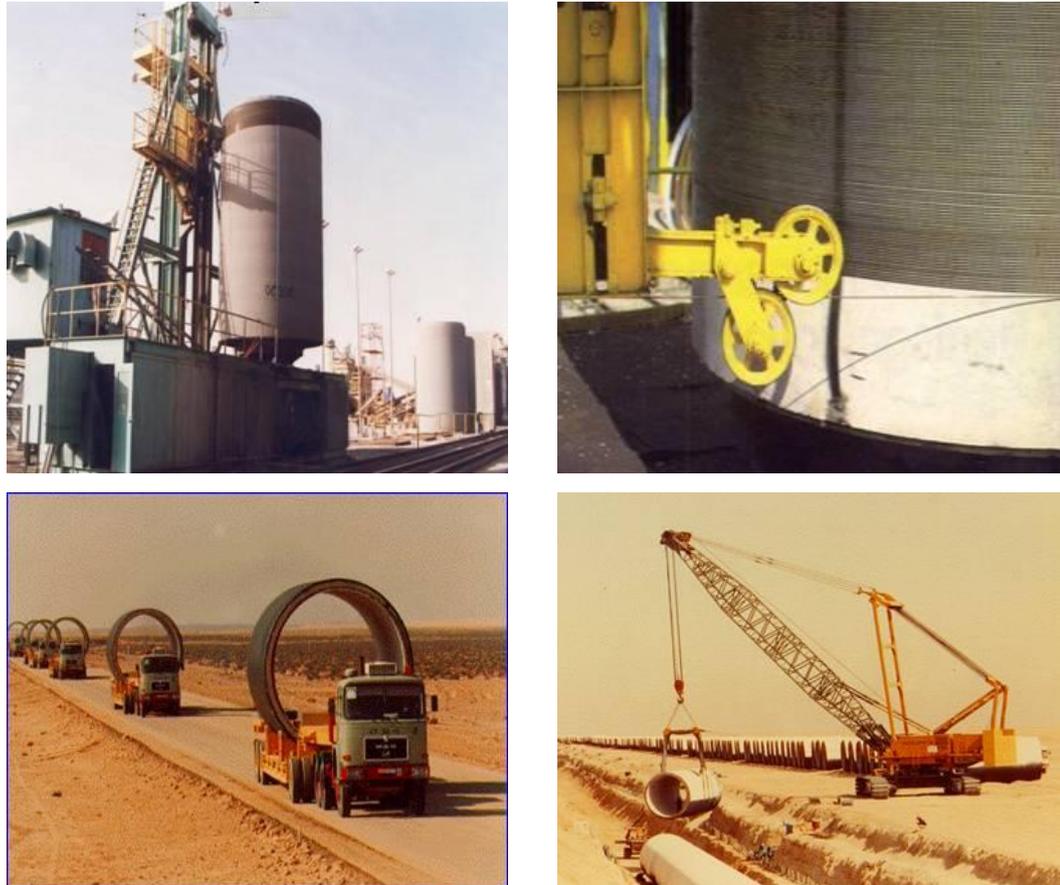
diameter, pitch and number of layers during pipe manufacture as shown in Figure 1.3. In order to protect the pipelines from the risks including temperature variations and other environmental conditions they are laid in seven metre deep trenches.

Figure 1. 3 Pipe Construction

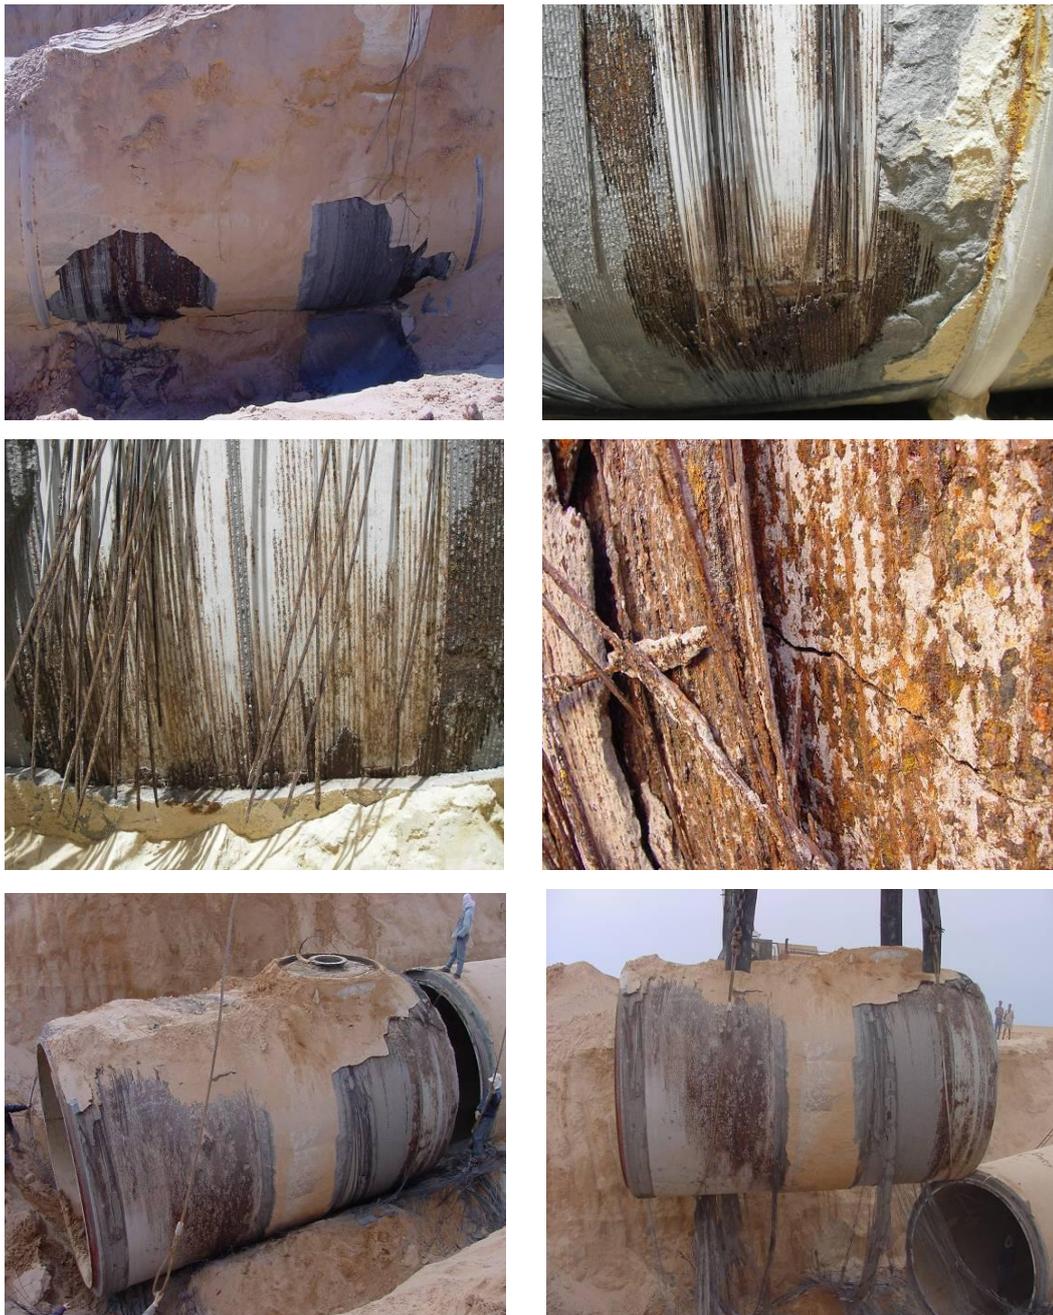
Due to prestressed wire corrosion in the concrete pipes induced by chloride ions absorbed from the aggressive soil, five catastrophic failures in four metre diameter white pipes have occurred after ten years of operation. The first failure was in August 1999 in the Sarir-Sirt (ss) line. The following month another pipe failed on the parallel Tazerbo-Benghazi line of the SS/TB conveyance. Three more failures, one on the Sarir-Sirt line and two on Tazerbo-Benghazi line occurred between January 2000 and April 2001. The

main reason for the damage is corrosion of prestressed wires in the pipes due to attack from the chloride ions from soil. Detection of the corrosion in initial stages has been very important to avoid other failures and the interruption of water flow. Figure 1.4 shows photographs of corrosion of the prestressing wires and examples of pipe failures.

Figure 1. 4 Pipe failures

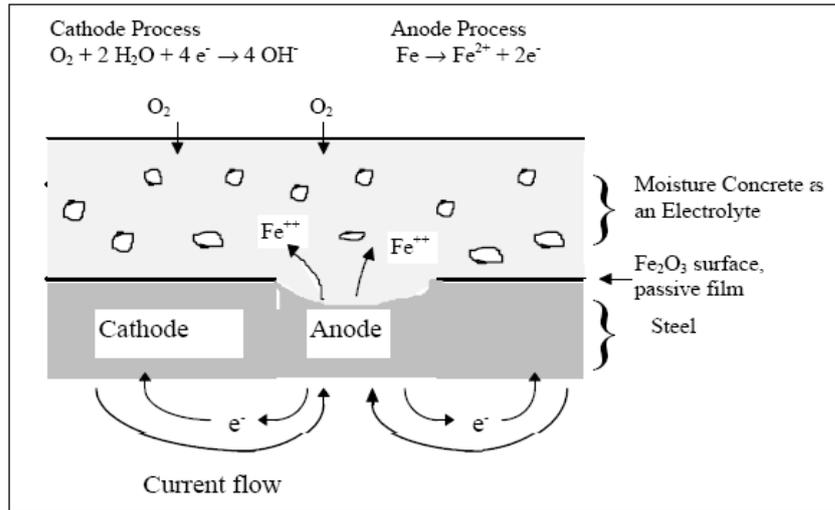
Hydroxyl ions migrate towards the anode and react with the ferrous ions to form ferrous hydroxide $\text{Fe}(\text{OH})_2$ as shown in Figure 2.2 and Equation 2.8:

Figure 2. 2 Mechanism of corrosion of steel in concrete (Schiesl 1988)

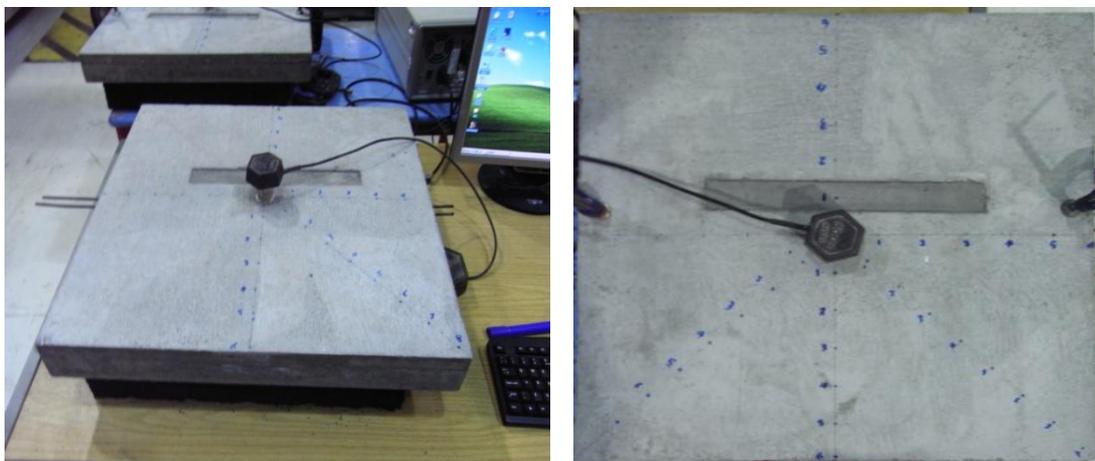
Figure 3. 1 Concrete and mortar specimen

Three lines were drawn; the first line was drawn parallel to the length of the wires from the sensor (centre) to the mortar edge then divided into six mark points 50 mm apart, a second line was drawn perpendicular to the wires from the sensor to edge, again with six positions at 50 mm centres. Finally a third line was drawn at a 45° angle to the wires from centre to edge. This was divided into eight points. The distance between these points was again 50 mm as shown in Figure 3.2.

In addition, a position located on the edge of the specimen was used to investigate the effect of out of plane waves in relation to the sensor position. Experiments were performed by using an artificial H-N source at the located marks on the three lines which were denoted as L, C and A respectively. The source was repeated five times at every mark and the signals were recorded.

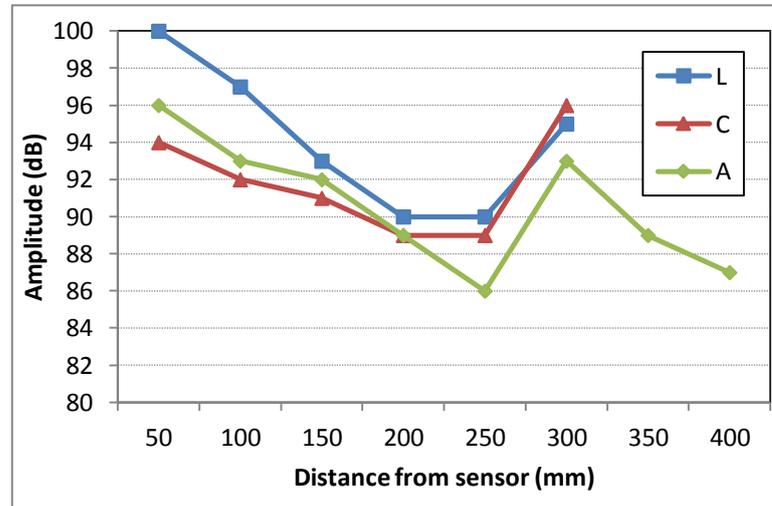
Figure 3.3 shows the attenuation presenting the average amplitude in dB detected from H-N source versus distance from the sensor for waves propagating in three directions (L,C and A).

Figure 3. 3 Attenuation of signal with distance in three directions

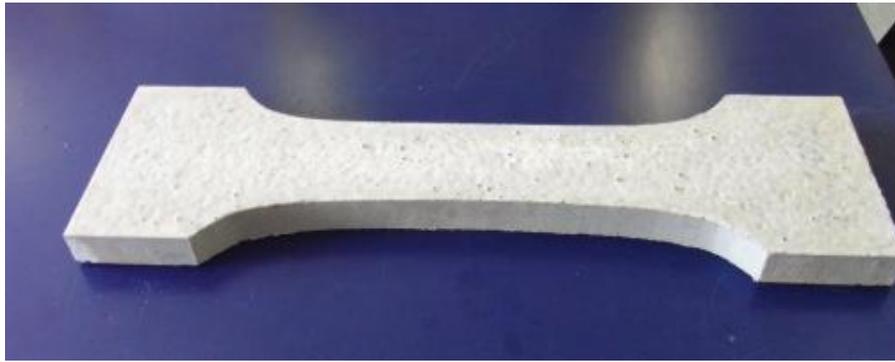
Figure 3. 7 Concrete specimen

The dog-bone type shape as shown in Figure 3.7 ensures a central area in which the tensile stress is uniform and well defined.

The dog-bone type shape has 740 mm length (500 mm of which is the spline), 100 mm width at the specimen's centre which increases gradually to 200 mm at the end of the spline and 35 mm thickness. Two specimens were prepared for testing. A combination of bonded plates and pinned plates was used to grip the specimen. This type of grip was adopted because it had proved effective previously (Benson 2003). A pair of plates was bonded, at both ends, using a commercial bonding agent (Sika bonding -Sikadur 31). In order to ensure that the adhesive had achieved its full strength, the specimens were left in the jig for 24 hours. These plates were pinned to a top plate which was attached to a coupling with a pin.

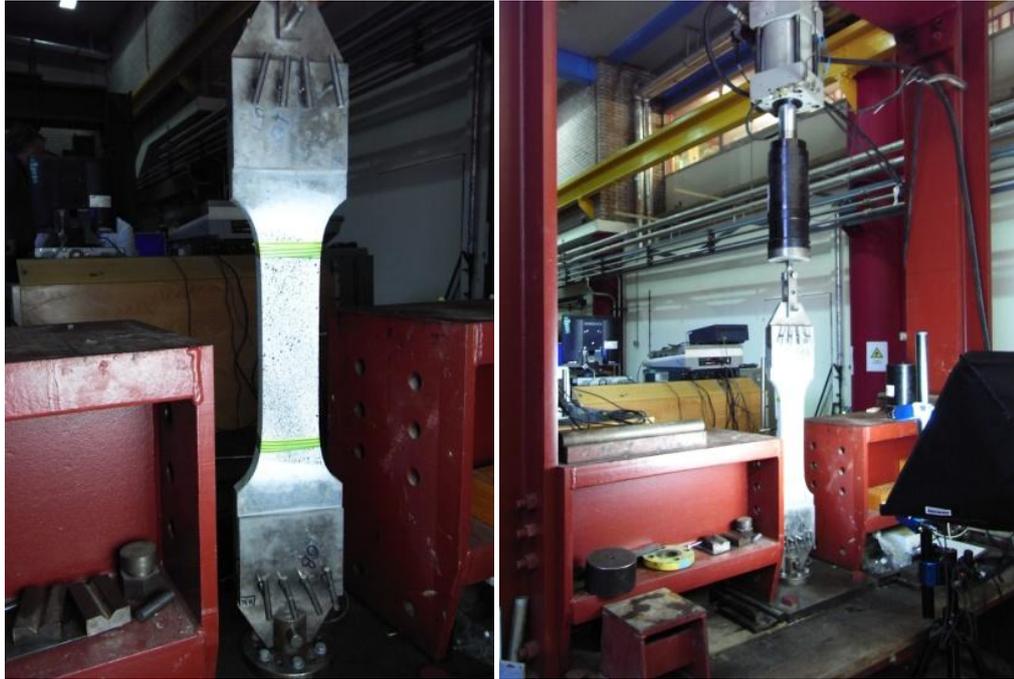
Two AE sensors (R3I – resonant frequency 30 kHz) were mounted to the centre of the mortar surface. The AE sensor was mounted using silicon sealant and fixed by adhesive tape. The AE systems hardware was set-up with threshold level of 40 dB and the sensitivity of the mounted sensors was checked by using the Hsu-Neilson source (Hsu 1979). The specimen was loaded gradually in tension and the AE system recorded the hits up to final failure. Figure 3.8 shows photographs of the specimen and the loading arrangement.

Figure 3. 8 Photographs of concrete specimen in the test machine

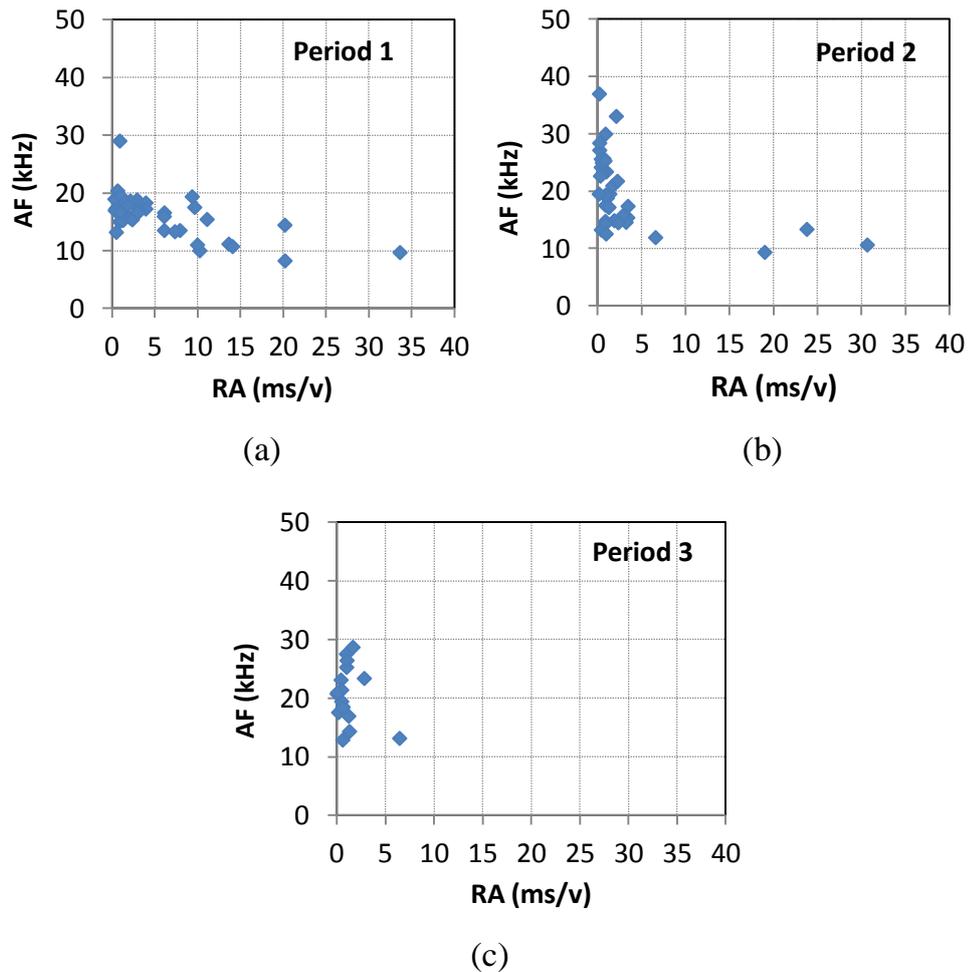
Figures 3.12 (a, b and c) show the relationship between the RA value and average frequency of the three periods. Figure 3.12 (a) shows the relationship between RA value and AF for period 1 which is associated with the early period of the test before any crack occurred. It can be seen that most of the data points have wide RA value (RA values 0-25 ms/v) and with low AF values (less than 20 kHz). Figure 3.12 (b) shows the relationship between RA value and AF for period 2 associated with the period directly before failure. It can be seen that there is a tendency for the data points have a narrower range of RA values with higher AF values. However Figure 3.12 (c) represents the relationship between RA value and AF for period 3 the failure period. It can be noted that in this period the most of the data points have various AF and low RA value (less than 5 ms/v).

Figure 3.12 Relation between the RA value and average frequency of (a)Period 1, (b) Period 2 and (c) Period 3

It can be seen that the results in Figures 3.20 (a, b and c) exhibit very similar behaviour as those in Figures 3.12 (a, b and c) in test 1.

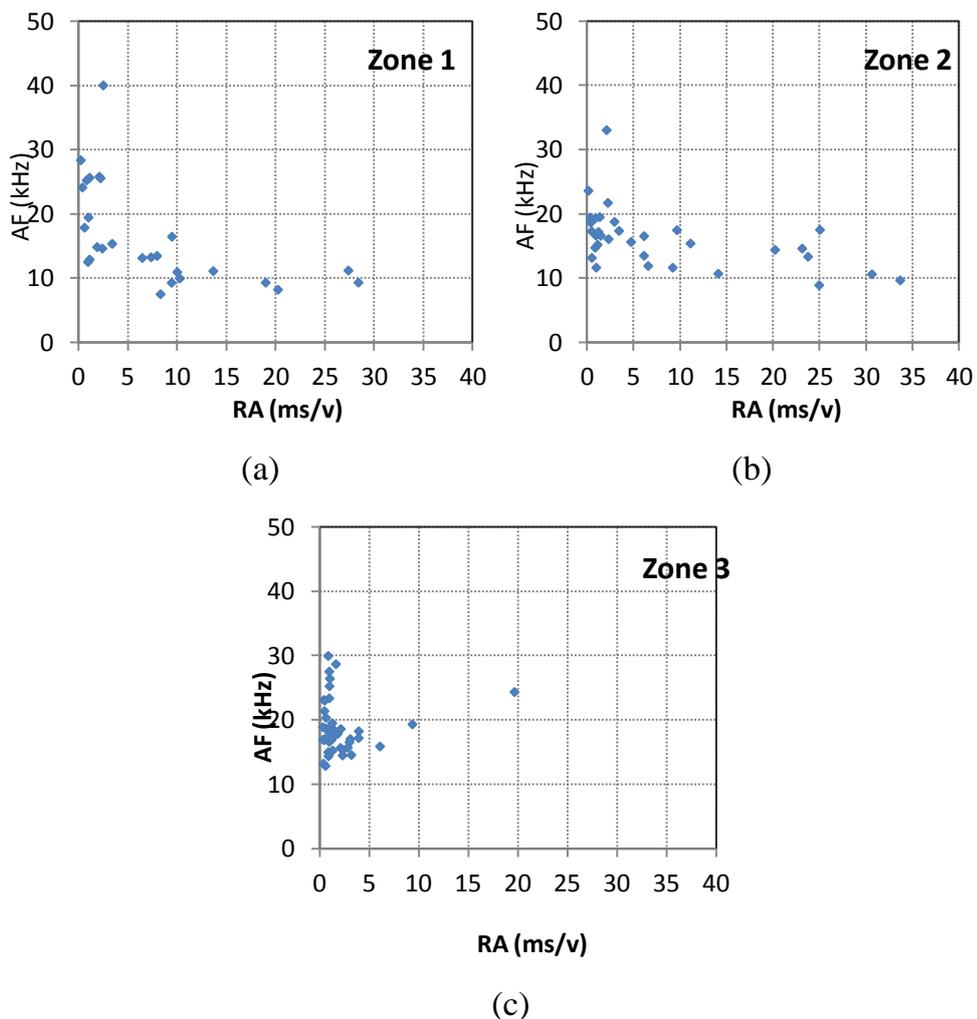
Figure 3.16 (a, b and c) show the AF vs. RA values for the different three regions. Figure 3.16 (a and b) show the AF vs. RA for zones 1 and 2 which are associated with the no crack regions. It can be noted that in these areas the RA value have a wide distribution (RA values 0-35 ms/v). Figure 3.16 c shows the relationship between RA value and AF of zone 3 associated with the tensile crack type region. It can be seen that the most of data points have various AF and low RA value (less than 3 ms/v).

Figure 3. 16 Relation between the RA value and average frequency of (a)zone1, (b) zone2 and (c) zone3

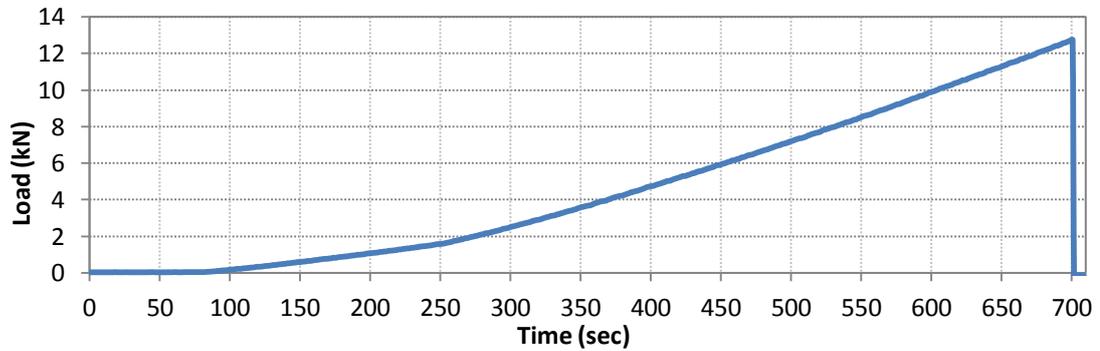
Similar behaviour was observed in test 2. The variation of load applied against time is shown in Figure 3.17. The applied load was started with small rate (0.001 mm/s) until 250 sec then increased (0.002 mm/s).

Figure 3. 17 Applied loads vs. Time

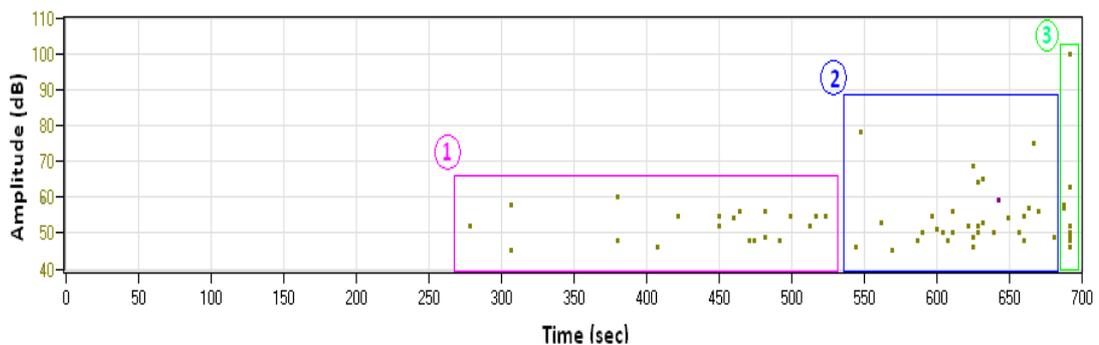
It can be seen that the first hits occur before 300 seconds when the applied load reaches 2kN and the final failure occurred at 12.74 kN (695 sec).

Figure 3. 18 Amplitude vs. Time

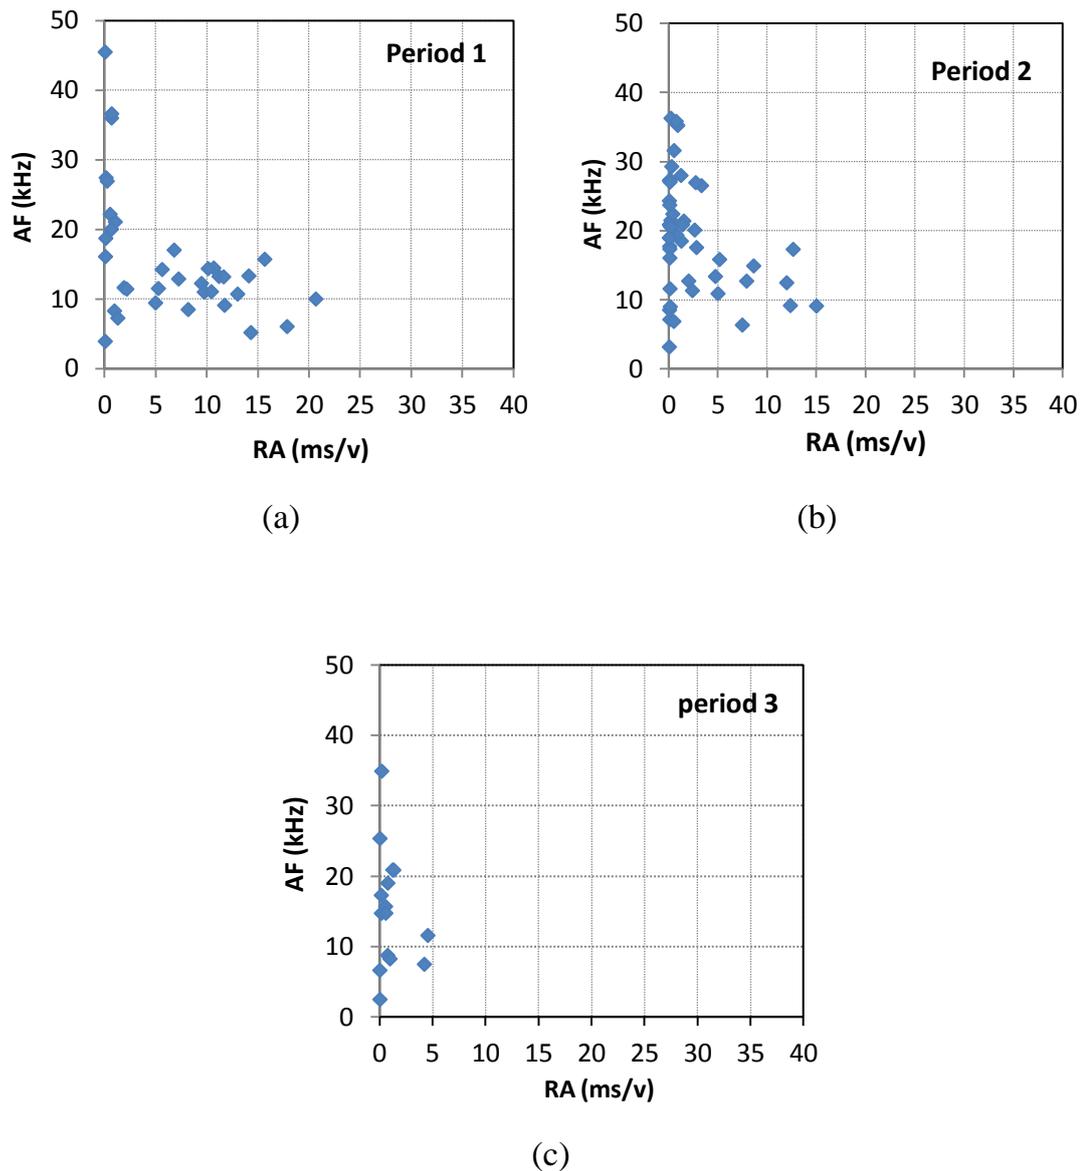
Figure 3. 20 Relation between the RA value and average frequency of
 (a) period 1, (b) period 2 and (c) period 3

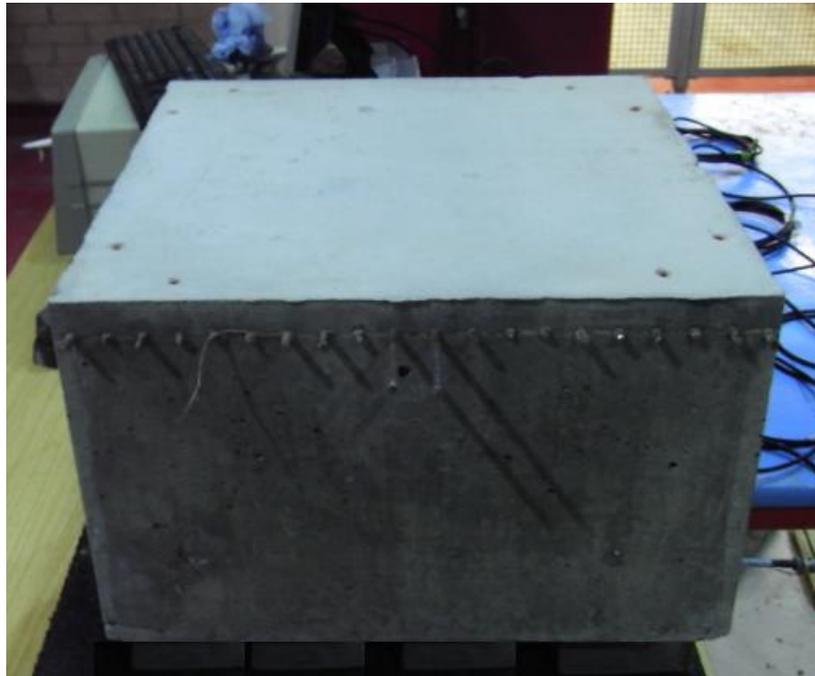
Figure 3. 21 Schematic diagram and photograph of specimen

A concrete specimen (400×400×230mm – termed a medium size specimen) with a steel plate (400×400×1mm) was cast. Wires were placed on the upper surface of this specimen then the mortar 400×400mm and 20 mm thickness was coated on the upper surface of the concrete (The mortar consists of one part cement to not more than three parts fine aggregate by weight). The specimen was water cured for 28 days. The final construction is shown in Figure 3.21.

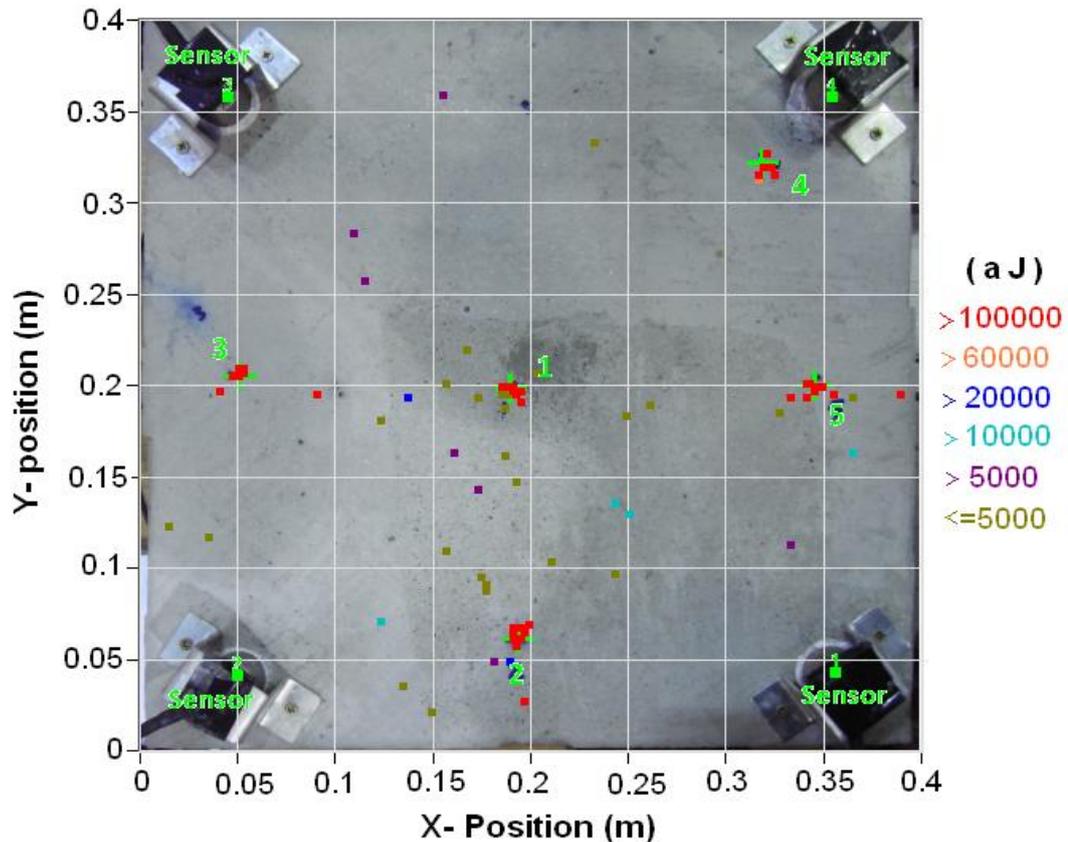
The location of events in Figure 3.24 a can be compared with Figure 3.23 which displays the planar location of sources on surface mortar in one Figure as shown in Figure 3.25.

Figure 3. 25 Comparison of the H-N source location points with energy of events location

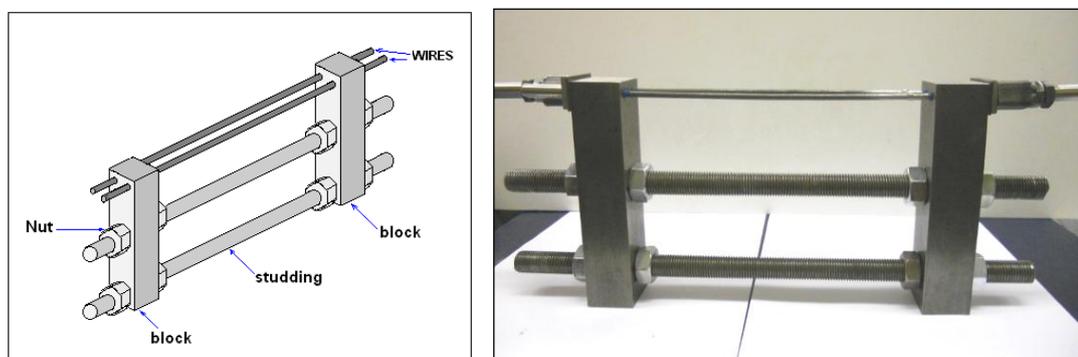
The frame consisted of two blocks (190mm x 45mm x 45mm) and two threaded steel bars (studding) having a diameter of 20 mm and a length of 500 mm. Two holes (20 mm diameter) and two (6mm) were drilled in each block. Figure 4.1 shows a schematic drawing for the tension holding frame. The two blocks were assembled via two threaded bars tightened by means of eight nuts.

Figure 4. 1 Tension holding frame

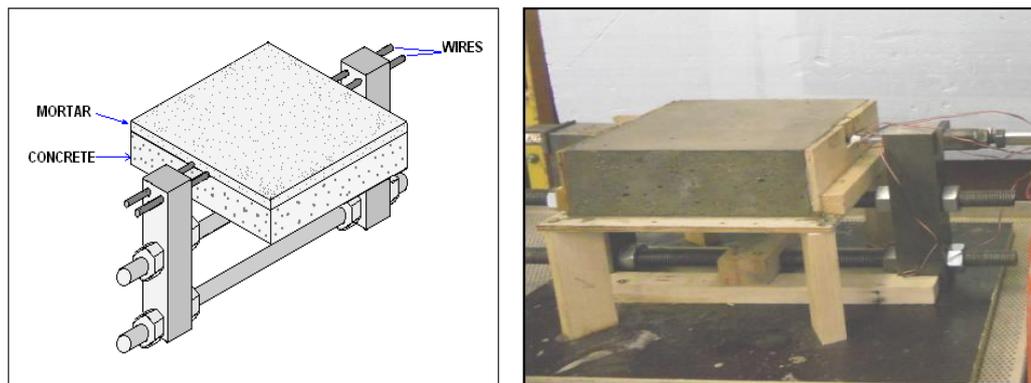
this specimen. The mortar 200×200mm and 20 mm thickness was coated on the upper surface of the concrete encasing the wires. The water to cement ratio used was 0.4 and the material proportions were 1:2:0.4 by weight of cement, sand and water respectively and the concrete design strength was 56MPa strength at 28 days. The mortar should consist of one part cement to not more than three parts fine aggregate by weight. The construction is shown in Figure 4.4.

Figure 4. 4 Concrete and mortar specimen

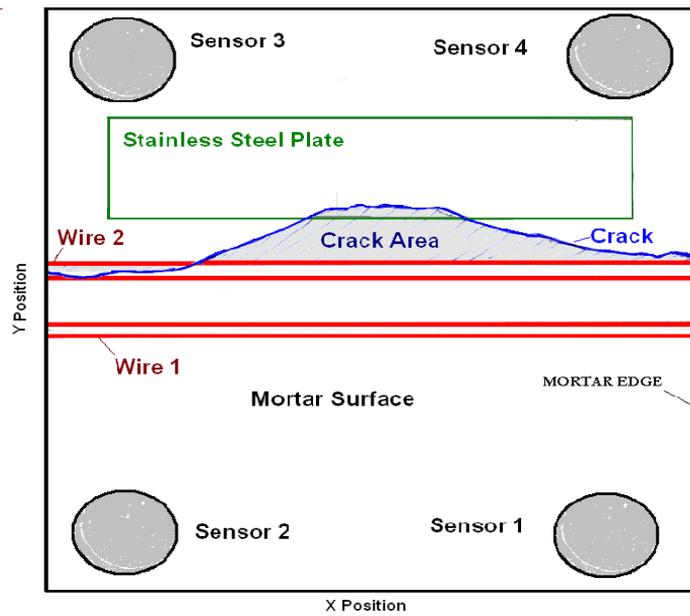
(a)

Crack shape, wires, stainless plate, and sensors mounted on the mortar surface are shown in Figure 4.8 a and b. Figure 4.8a is a schematic diagram of the specimen after testing. Figure 4.8b is a photograph of the top mortar surface after the finish of the test.

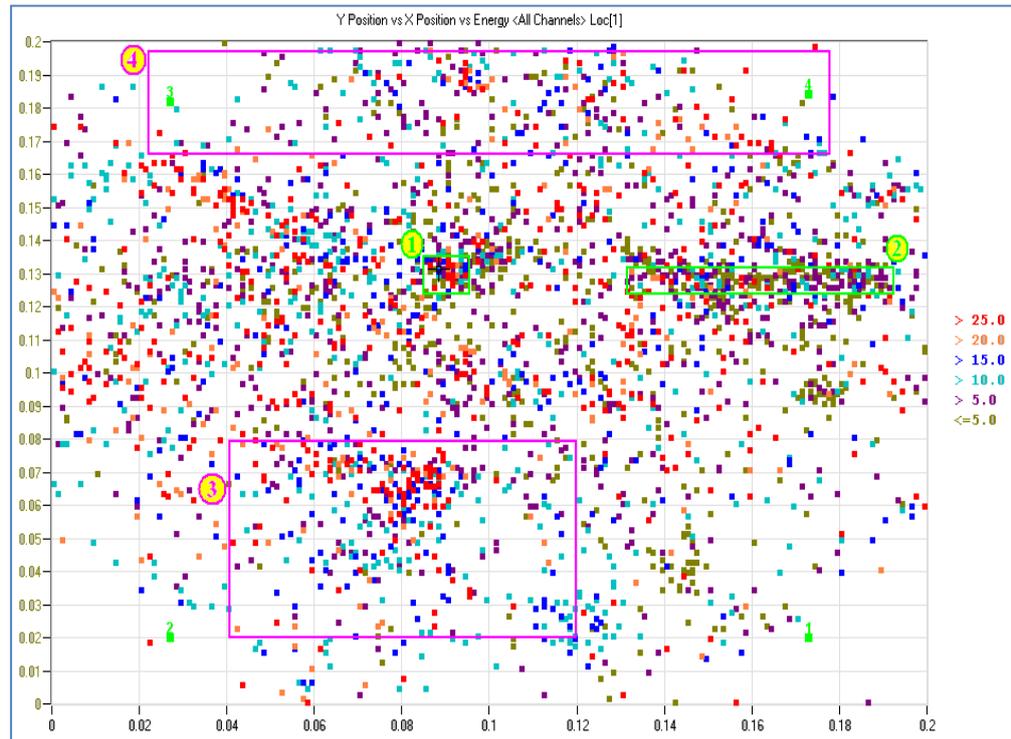
The location of hits with minimum amplitude 45dB for the whole period of the test is shown in Figure 4.9. It can be noted that the highest hits concentration and highest energy in the region coincides with the maximum wire corrosion products and the crack area which was visibly observed post test. Four zones have been chosen as examples to differentiate between cracks and non cracked areas (Figure 4.9).

Figure 4. 9 Source locations for whole test with amplitudes greater than 45dB

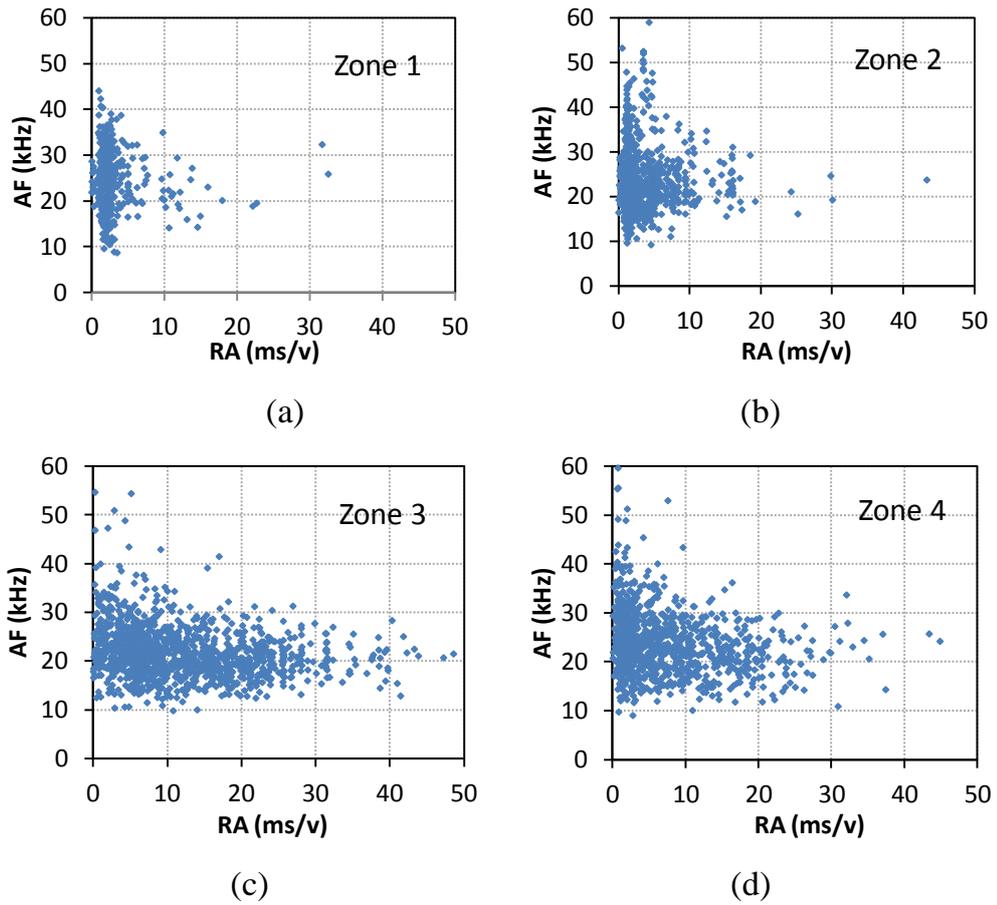
It can be seen that the majority of data points have various AF and low RA value (less than 5 ms/v). Therefore, based on Figure 2.5 (in Section 2.4.1) and Figure 3.12 (in Section 3.5.2), this indicates that this pattern represents a tensile crack. Furthermore, Figure 4.10 (c and d) shows the relationship between RA value and AF, for areas on the location with a low concentration of hits, where there was no tensile crack. It can be noted that the RA value has a wide distribution (0-50 ms/v).

Figure 4. 10 Relation between the RA value and average frequency of (a)zone1, (b) zone2, (c) zone3 and (d) zone 4

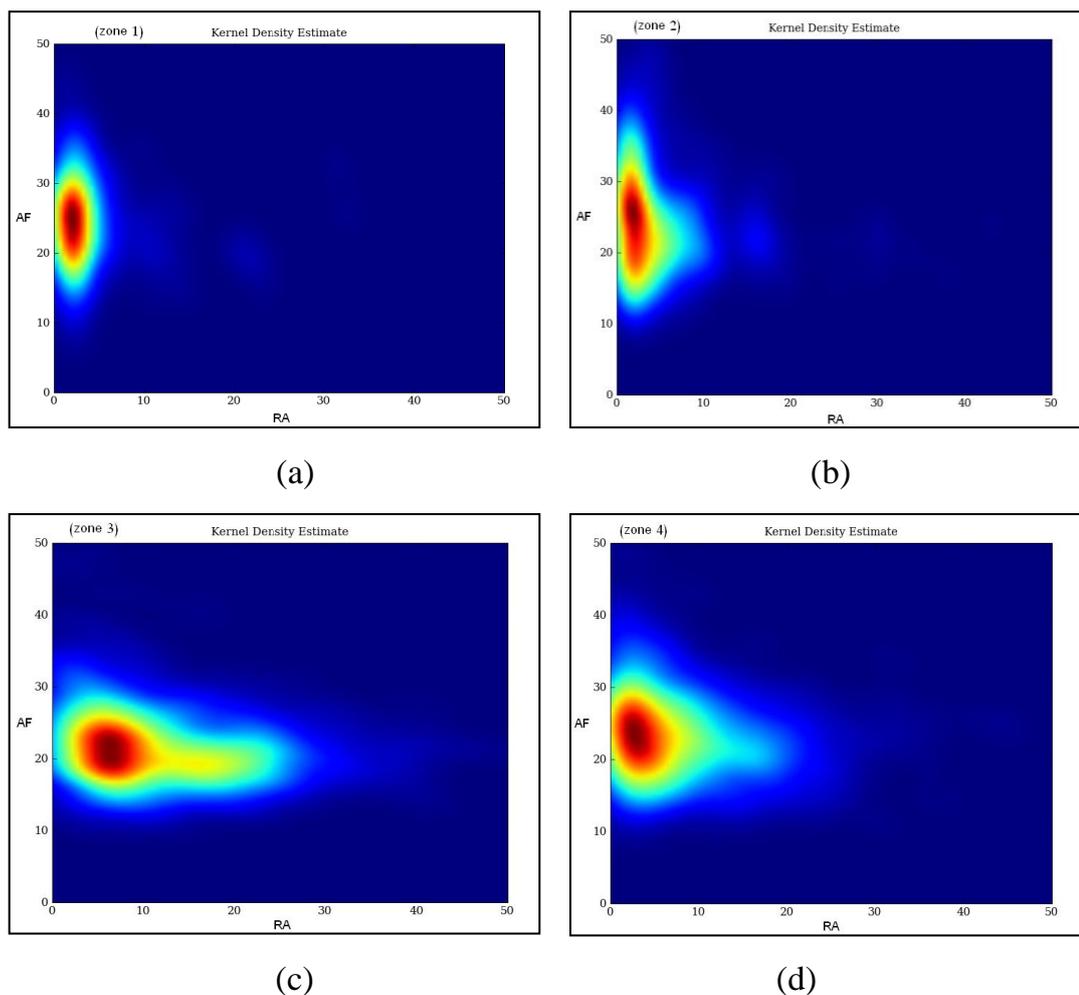
Furthermore, these areas can be visualised using Kernel Density Estimation Function (KDEF) as shown in Figure 4.12 (a, b, c and d). Regions of high concentration are more easily identified. The concentration value of the data is represented by different colours, brown for the highest number of data points and blue for lowest.

Figure 4.12 Kernel Density Estimation Function of (a) zone 1. (b) zone 2, (c) zone 3 and (d) zone 4

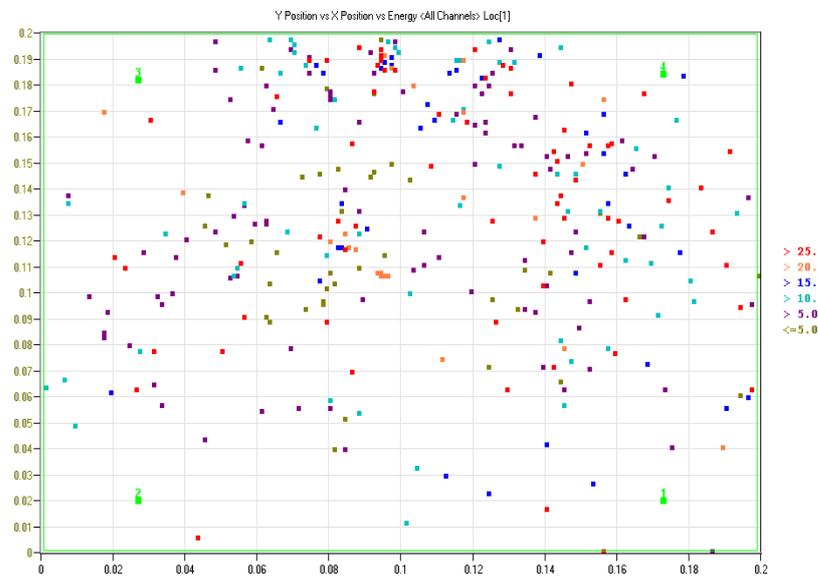
Furthermore, Figure 4.15 shows the source location of signals within period 1. It can be seen that the number of hits and energy is small. All collected signals were analysed using the RA/AF comparison which is presented in Figure 4.16. It can be noted that the distribution of data points is a mixture between vertical and horizontal which is representative of tensile cracking together with other non-crack signals, i.e. a mixed area.

Figure 4. 15 Source locations for first three days (Period 1)

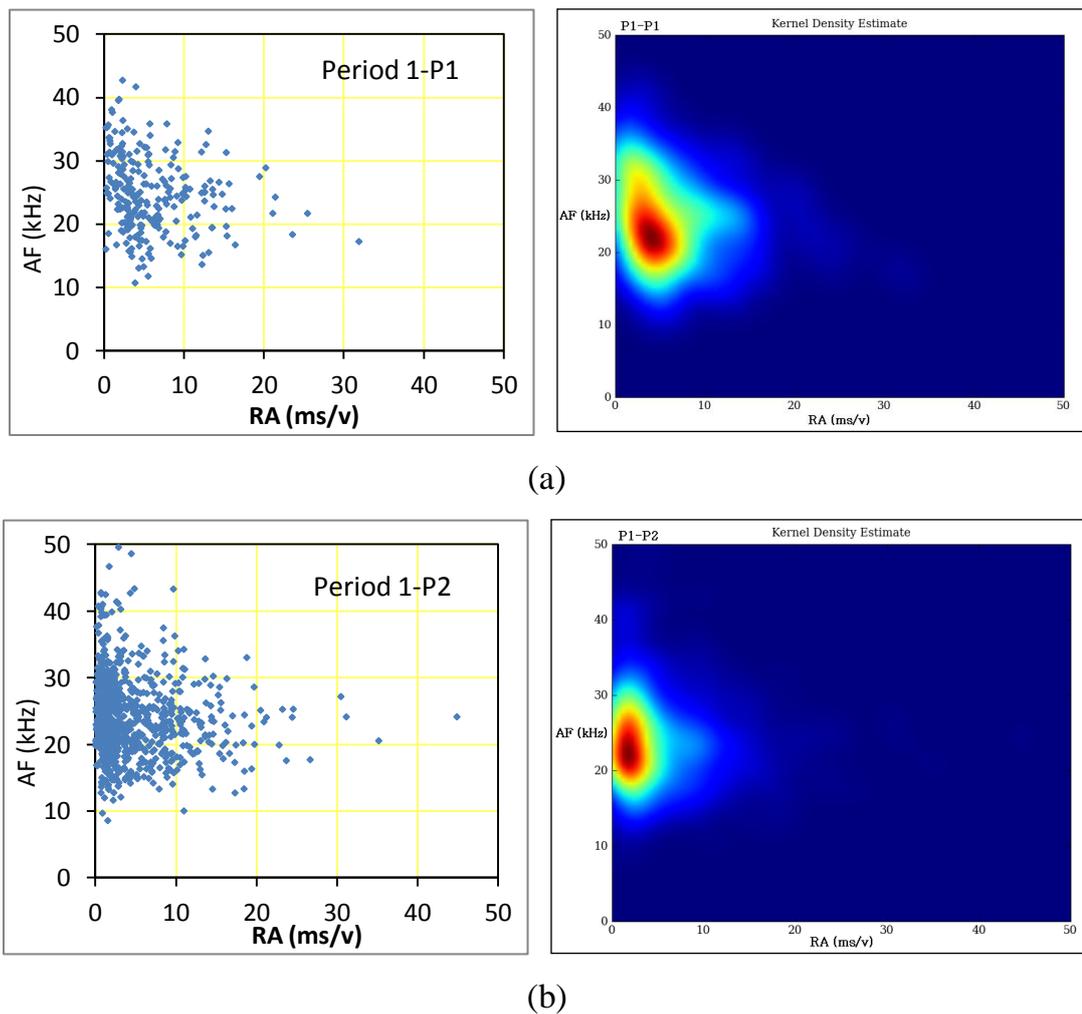
By presenting these periods via a graph and KDEF as shown in Figure 4.17, it can be noted that the RA vs AF relationship is different for the two periods. In the second period the shape is more vertical which is indicative of tensile cracking.

Figure 4.17 Relation between the RA value and AF of a and b period of period 1 (a) before and (b) after small increase of hits and energy.

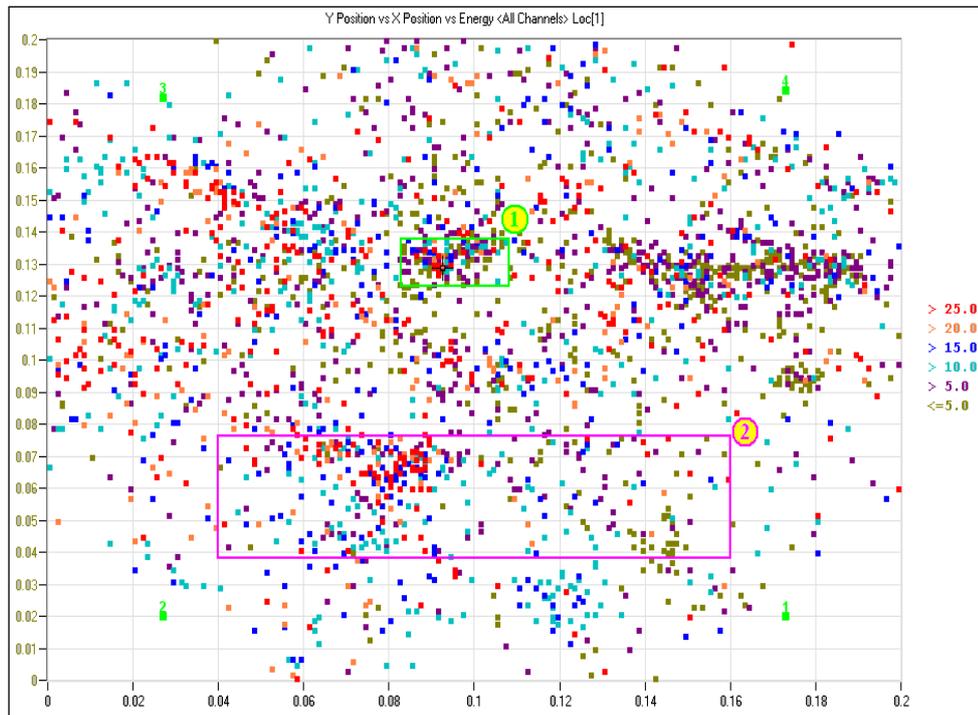
it can be seen that in Figure 4.18 the number of located events increases considerably due to an increase in the number of macro cracks, crack propagation and the split of mortar from concrete, as observed visually. Also, a high concentration of hits in the observed area of cracking should be noted.

Figure 4. 18 Source locations for middle three days (Period 2)

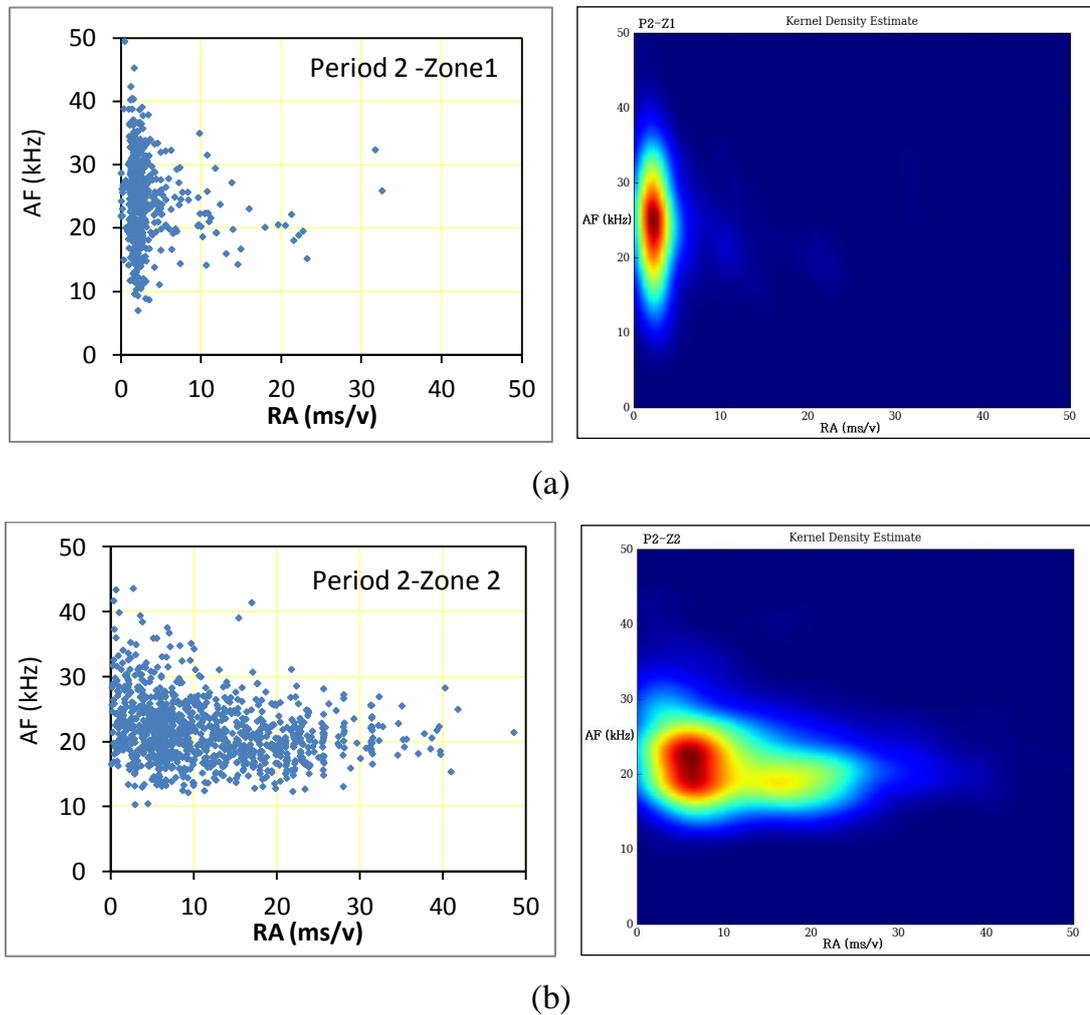
Conversely, in the Fig 4.19b (zone 2), there is a horizontal trend (low RA-value and wide variation of AF-value).

Figure 4. 19 Relation between the RA value and AF of (a) Zone1 and (b) zone2

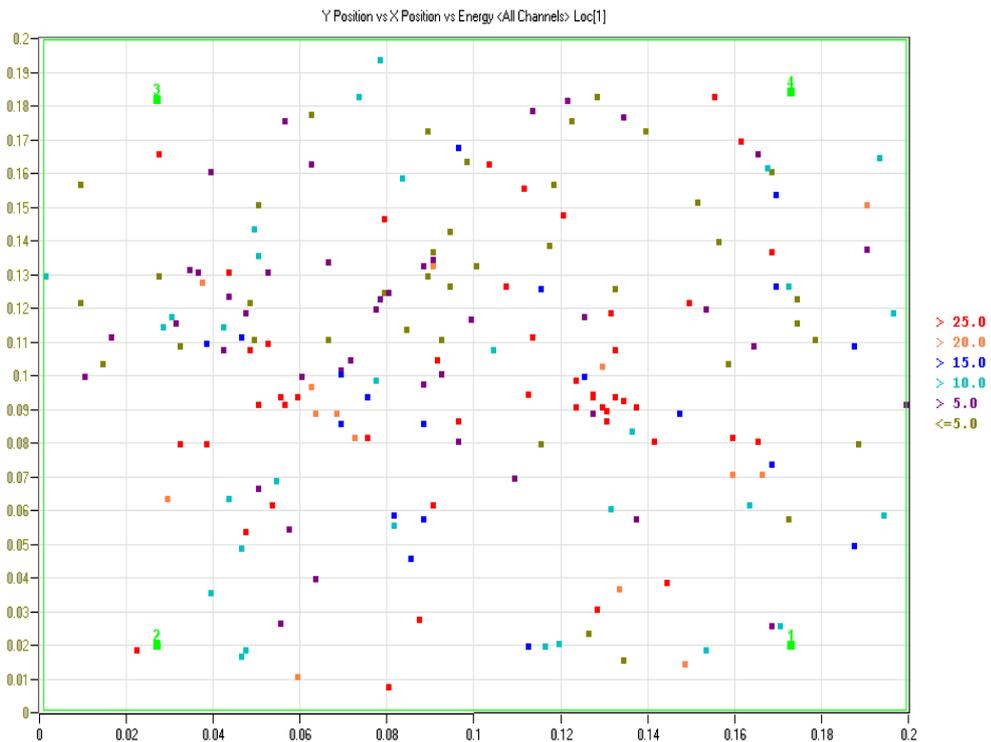
During the final three days (period 3 in Figures 4.13 and 4.14) it can be noted that the energy decreases for two reasons; firstly all the cracks had opened at this point as observed visually and secondly due to the decrease of current (corrosion rate) and hence a decrease in the effects of corrosion on the concrete. In addition, Figure 4.20 shows source location on the mortar surface. It can be seen that the number of hits is decreased compared with period two.

Figure 4. 20 Source location for last three days (Period 3)

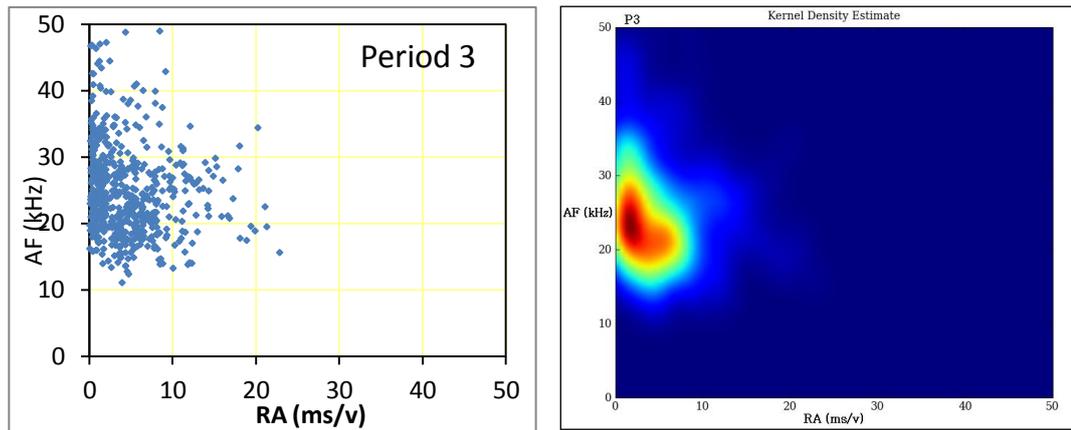
The decrease in the number of crack propagation hits is due to the decrease in the corrosion activity (current applied) and the crack extending in the concrete above and along the wire becomes very slow (or completely opened).

Figure 4. 21 Relation between the RA value and AF of period 3
