***ACOUSTIC EMISSION ANALYSIS OF
PRESTRESSED CONCRETE STRUCTURES***

PhD Thesis

***School of Engineering
Cardiff University, Cardiff
UK
May 2013***

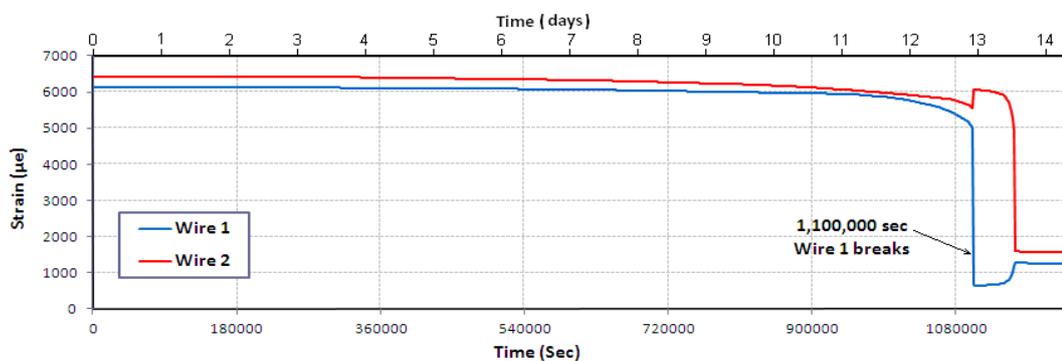
The highest energy and highest amplitude (100 dB) located in stage 4 is due to the wire 1 breaking as observed both in visual inspection and at this time the strain gauge reading suddenly decreased from approximately 6000 to around 500 μ strain .

Figure 4. 25 Recorded strain for duration of investigation

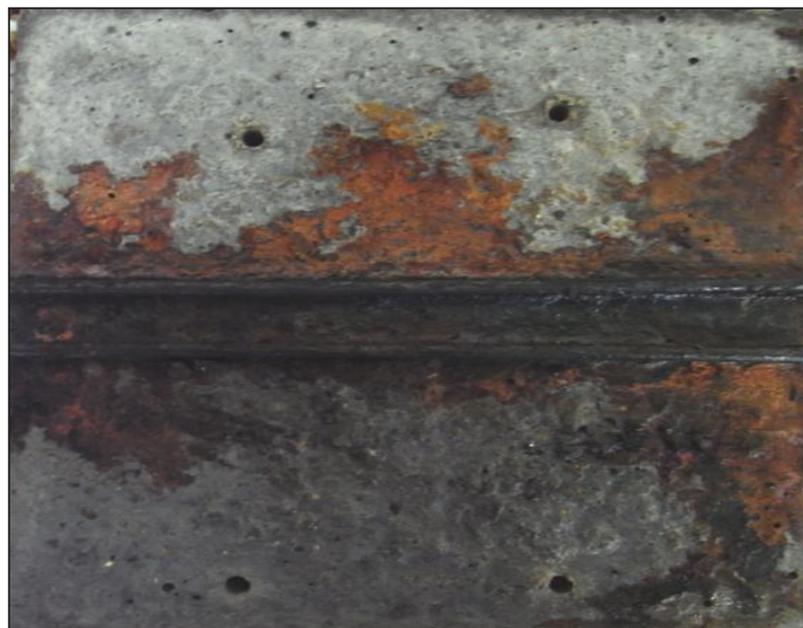
Figure 4. 28 Photo of upper concrete surface and wires

The corroded wires and corrosion product once the mortar had been removed is shown in Figure 4.28. It is evident that significant corrosion occurred in the upper wire and it was in this location that a large majority of AE signals were detected and located.

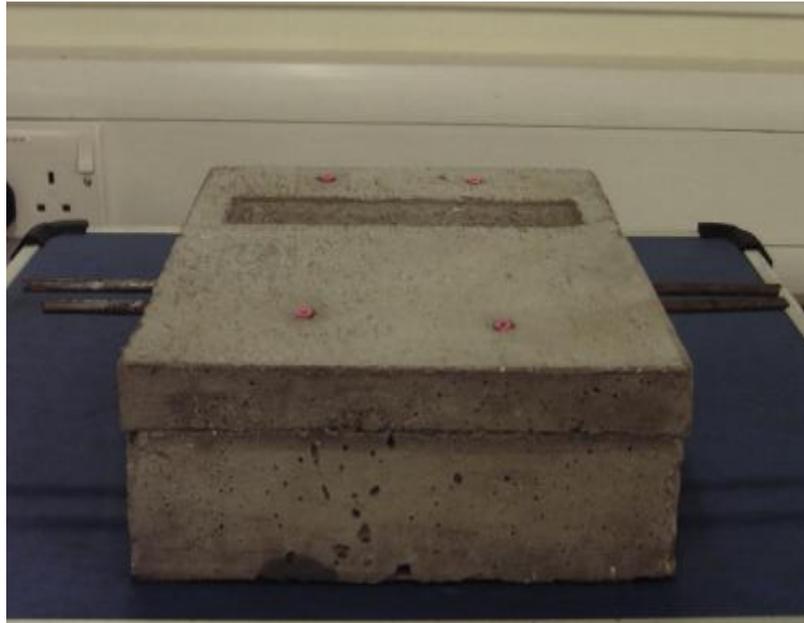
Figure 4. 46 Concrete and mortar specimen

Three days later, after the concrete specimen had completely cured, two wires (80 mm length and 4.88 mm diameter) combined were placed on the upper surface of this specimen. The mortar 200×200mm and 20 mm thickness was coated on the upper surface of the concrete. The water to cement ratio used

was 0.4 and the material proportions were 1:2:0.4 by weight of cement, sand and water respectively and the concrete design strength was about 56MPa strength at 28 days. The mortar should consist of one part cement to not more than three parts fine aggregate by weight. The construction is shown in Figure 4.46.

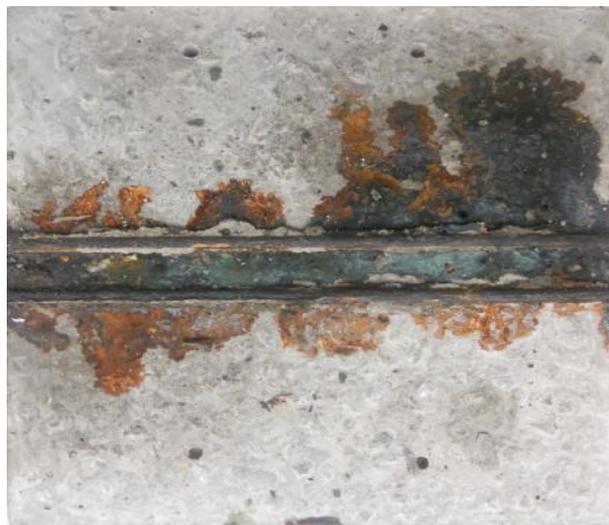
Figure 4. 50 Photo of upper concrete surface and wires

The corroded wires and corrosion product once the mortar had been removed is shown in Figure 4.50. It is evident that significant corrosion occurred in the upper wire and it was in this location that a large majority of AE signals were detected and located.

AE monitoring was conducted for approximately seven days. As previously, to eliminate background noise a threshold of 48dB was used, this was found to provide a better distinction of location regions, the location of signals with minimum amplitude 48dB for the whole period of the test is shown in Figure 4.48. It can be noted that the highest hits concentration and highest energy region coincides with the position of maximum wire corrosion and the crack which was visibly observed post test as shown in Figures 4.49 and 4.50.

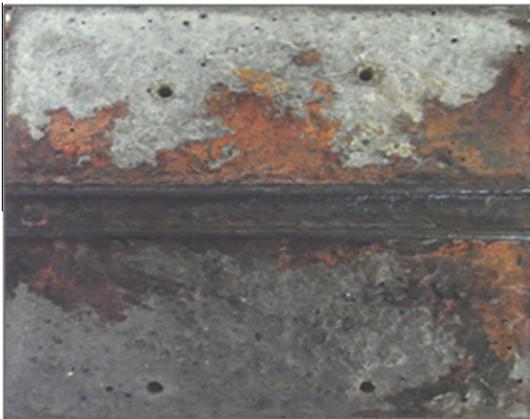
Fig. 13. Photo of upper concrete surface and wires.

The corrosion wires and corrosion product once the mortar had been removed is shown in Fig. 13. It is evident that significant corrosion occurred in the upper wire and it was in this location that a large majority of AE signals were detected and located.
