## The impact of modernization of a 16th century timber-framed farmhouse, Suffolk, UK

**Abstract** – *Well intentioned modifications to traditional buildings can potentially be detrimental if the full implications of the work are not fully understood. This paper presents the case of a 16th century Suffolk farmhouse. Extended in the 1700s, the timber-framed building was clad in cement render in the early 20th century. At a later date the timber sole plates were encased in concrete and painted with an impervious resin. Finally in 2005 the panel infills were replaced with rigid polyisocyanurate (PIR) thermal insulation. In-situ environmental monitoring and digital simulation are used to assess the impact of these measures on the performance of the building. The outcomes of this research are now being used to enhance the informed conservation of this building.*

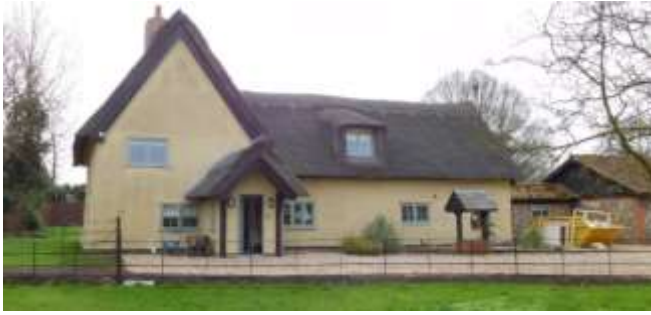
**Figure 1. North entrance elevation of case study. Source: (Author's own, 2017)**

The oldest section of the house, the lower wing (right in Figure 1), contains a small section of 16<sup>th</sup> Century plain crown post roof structure [7]. A second, taller wing is thought to have been constructed at right angles to the first in around the 17<sup>th</sup> century, with an axial red brick chimney with sawtooth shaft (ibid). Subsequent additions were added in the 1980s with a porch to the north (Figure 1), an en-suite bathroom at the junction of the two wings (Figure 2) and a service block to the west.

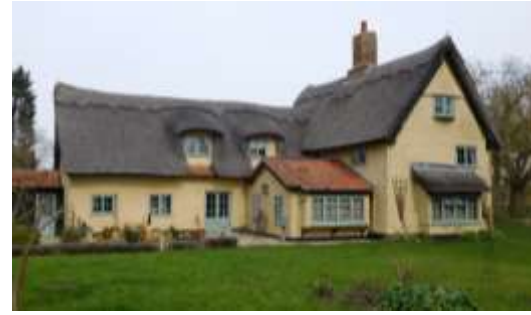
**Figure 2. South, elevation. Source: (Author's own, 2017)**
