PLEA 2017 EDINBURGH

Improving the Energy Performance of Historic Timber-Framed Buildings in the UK.

Christopher J. Whitman¹, Oriel Prizeman¹, Julie Gwilliam¹ and Pete Walker²

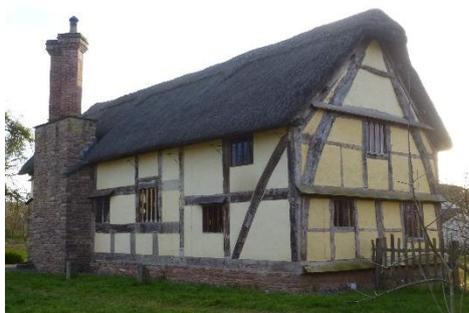
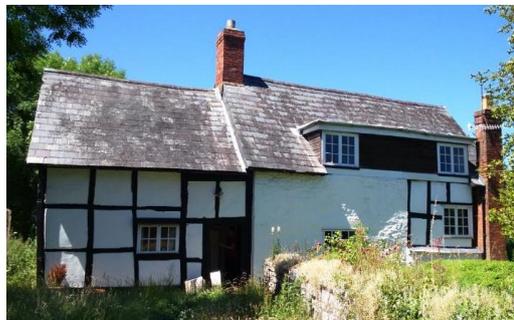
Figure 1 Hacton Cruck, Preston-on-Wye Figure 2 The Oaks, Brockhampton and Figure 3 The Old Mayor's Parlour Hereford. Source: (Author's own, 2015)

The three case study buildings presented in this paper are, Hacton Cruck (Figure 1), a mediaeval peasant hall, now let as holiday accommodation; The Oaks (Figure 2), an estate cottage built over three centuries, now owned by the National Trust and let as a single-family residence; and The Old Mayor's Parlour (Figure 3), a gallery space, managed by a charitable trust, whose origins date back to the 14th century. As such, the case studies represent a variety of ownership models, tenancies and uses. Hacton Cruck and The Old Mayor's Parlour have undergone substantial retrofits and display a variety of different panel infills, both old and new. The work on these properties was designed and overseen by a local, sole practitioner architect. In contrast, The Oaks has had minor retrofit interventions with no change to the existing wall construction, and the works were specified by the estate surveyor in line with the National Trust's environmental standards. The construction work at The Oaks was undertaken by a small building contractor; at The Old Mayor's Parlour by a conservation contractor; and at Hacton Cruck by the building owner in collaboration with professional conservation contractors.

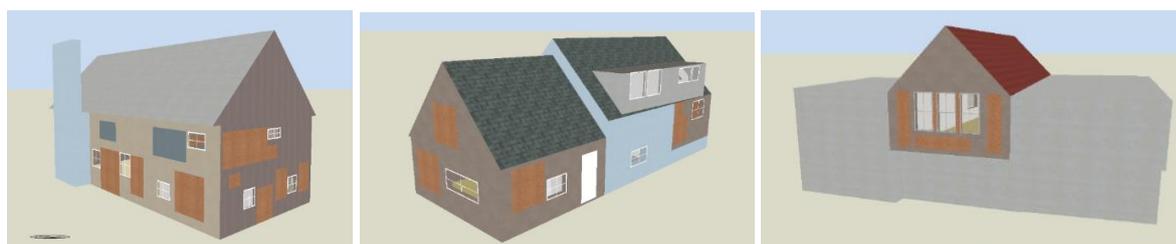
Figure 7. DesignBuilder models of (from left) Hacton Cruck, The Oaks and The Old Mayor's Parlour. Source: (Author's own, 2017)

For the building thermal zone calculation, EnergyPlus uses a heat balance model based on the assumption that the air in each building zone is homogenous with no stratification of temperature (Crawley et al., 2001 p323). As such there is no requirement for the height of differential wall materials to be accurately modelled. The complicated timber-frame was therefore simplified to block sub-surfaces, the area of which accurately represents the area of timber-frame, if not its precise location and configuration (Figure 7).
