# **Audible Acoustics for Detecting and Locating Damage in Composite Structures**

Matthew Pearson and Rhys Pullin  
Cardiff University, School of Engineering  
Cardiff, CF24 3AA, Wales  
pearsonmr@cardiff.ac.uk

Eszter Szigeti  
Airbus  
Filton, BS34 7PA, UK

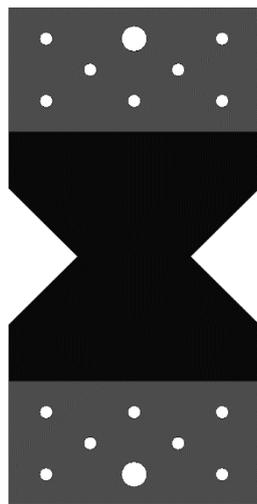
Figure 1. Specimen with the clamping plates

The composite specimens were manufactured from uni-directional Hexcell M21/35%/UD268/T800S pre-preg material and cured in an autoclave at 180 °C for 2hrs. The specimen dimensions were 200 x 400 mm with a layup of (0,60<sub>2</sub>)<sub>s</sub> resulting in a nominal thickness of 1.5mm. Two V-notches with a depth of 55 mm were introduced at the centre line of the panel in order to promote damage at a specific location. Four Steel clamping plates were used to transmit the load to the specimens using 20 mm pins. The specimen and the clamping plates used for the investigation can be seen in Figure 1. An ultrasonic C-scanner was used to determine that there were no defects in the specimens prior to testing.

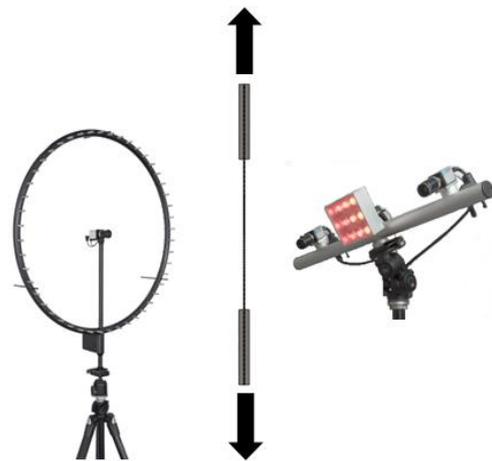
Figure 2. Experimental set-up

The specimen was loaded in five stages, the first increment was 0.5 kN to 10 kN, the remaining stages were increments of 10 kN to a peak load of 50 kN. The five loading stages were necessary due to the maximum recording time of the acoustic camera system at the specified sample rate. The load was held at the end of each incremental load stage while the audible data was downloaded from the acoustic camera system. After the peak load of 50 kN was reached the specimen was unloading from 50 kN to 0 kN at rate of 1.25 kN/s. Two non-contact measurement techniques were used to monitor the evolution of damage in the specimen. The first was a commercial acoustic camera system manufactured by gfai tech GmbH. The system comprises of a circular array of 48 equally spaced microphones and an optical camera at the centre of the array as seen in Figure 2. A gfai tech GmbH MC dRec acquisition system was used to record the audible acoustic waveforms at a sample rate of 192 kHz, at this particular sample rate the maximum recording duration was 43 seconds. A pre-trigger of 40 seconds was used and the system recording was triggered at the end of each incremental loading stage. The commercial Noiseimage software was used to determine audible signatures of interest and delay and sum beamforming was utilised to localise a noise source. The second monitoring technique was a DIC system, this is an optical technique that allows for the calculation of full field deformation and strain. Before testing commenced a black and white speckle pattern was applied to the back surface of the specimen using spray paint. A Dantec Q-400 DIC system with two cameras and the ISTRA 4D software package was used to monitor the specimen. A reference image was taken at zero load. Images were recorded every second throughout each incremental loading stage. The experimental set-up can be seen in Figure 2 where the Acoustic Camera and DIC systems were used to monitor different sides of the specimen.
