Characterisation of fatigue damage in composites using an Acoustic Emission  
Parameter Correction Technique

# Characterisation of Fatigue Damage in Composites Using an Acoustic Emission Parameter Correction Technique

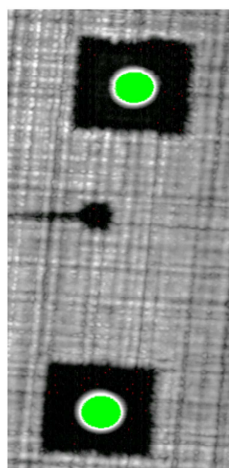
(a)

The C-scan images are shown in Figure 5 and reveal the different conditions of the panel during the test. After manufacturing, the C-scan image shows there is no internal damage (Figure 5a). After applying the first 26 loading batches (ending with 21 kN load after 130k cycles) the panel is still without any signs of

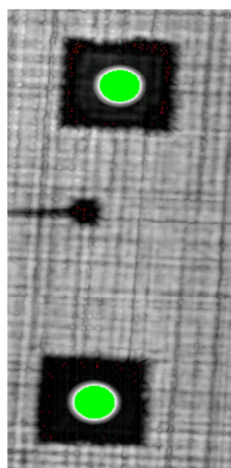
(b)

internal damage (Figure 5b). The artificial crack location indicates a very slightly higher attenuation, but it is difficult to identify in-plane cracking by C-scan inspection so this cannot be considered conclusive. After impact (Figure 5c), a clear region of high attenuation is observed just above the lower tab indicating the location of impact induced delamination. The dark spot seen centrally in all the images is sensor 5 with its cable exiting to the left of the image also visible. At the end of the test (31 kN load after 285k cycles) no discernible growth in the delamination area can be observed, suggesting that the delamination has not grown during the test (Figure 5d). Again a mild increase in attenuation at the cut plies (just below sensor 5) is observable in Figure 5d but no positive indication of matrix crack growth can be inferred from this.

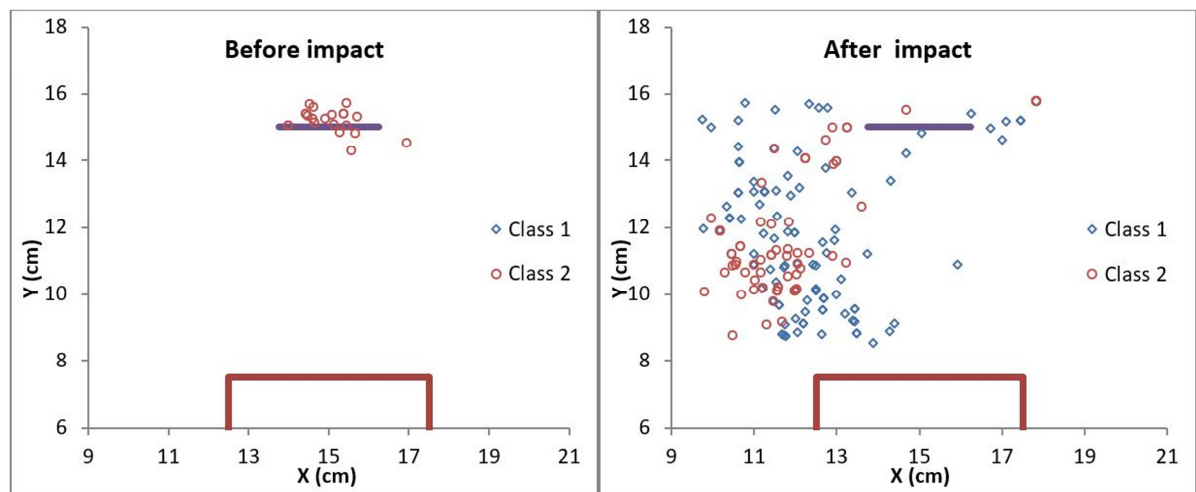
Figure 10. Delta T Mapping locations of the classification results (PCT).

The post impact stage contains events mostly located in the region of the delamination, with a small number of events located near the cut ply region, indicating that some additional matrix cracking might have been induced by the higher applied load of 31kN (Figure 10). Significant activity is seen in the delamination region, despite the C-scan data showing no obvious signs of delamination growth. The AE activity in this region is likely to result from a range of sources including matrix cracking caused by the induced stress concentrations and friction from fretting and movement of the existing damage surfaces. For the data recorded after impact the PCT classification identifies two classes (Figure 10). The signals located at the delamination site are a mixture of class 1 and 2, which is expected due to the varied damage mechanisms present in this area, with class 2 representing matrix cracking and class 1 representing fretting of the delamination surfaces. Out of the small number of signals located near the crack most are class 2 and located in the region of the crack tips and correspond to the observed matrix cracking.
