Prior, Jonathan 2016. Urban river design and aesthetics: A river restoration case study from the UK. Journal of Urban Design 21 (4) , pp. 512-529. 10.1080/13574809.2016.1187557 file

Urban River Design and Aesthetics: A River Restoration Case Study from the UK

Jonathan Prior, Cardiff University

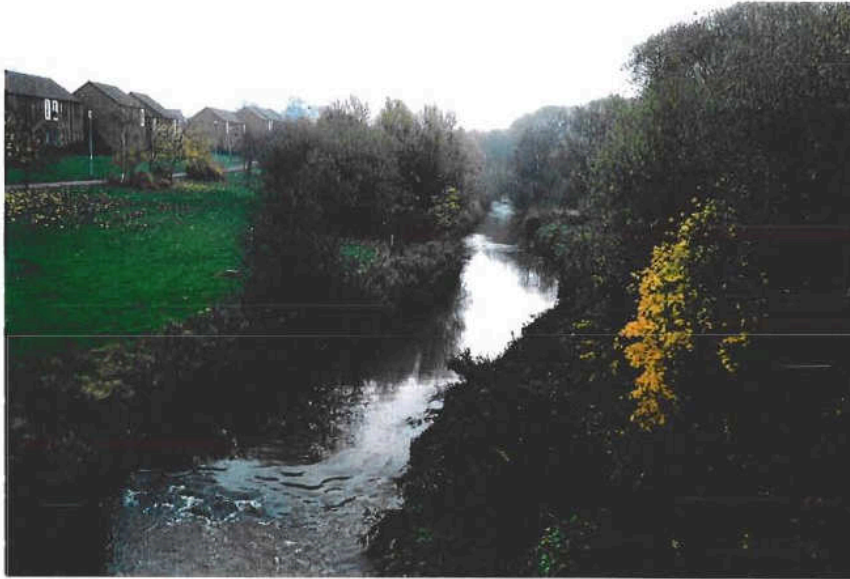
Section 2

‘the river has a soft edge on both sides with a fairly uniform profile’

‘industrial premises edge the right bank, these are located on an elevated plateau and are screened behind a densely vegetated embankment’

‘apart from the traffic noise on Albert Bridge the area is peaceful’

Figure 1. Selected photographs, descriptions, and classifications of the River Skerne from the Landscape Assessment (from SGS Environment, 1994, copyright the River Restoration Centre, reproduced with kind permission from the River Restoration Centre).

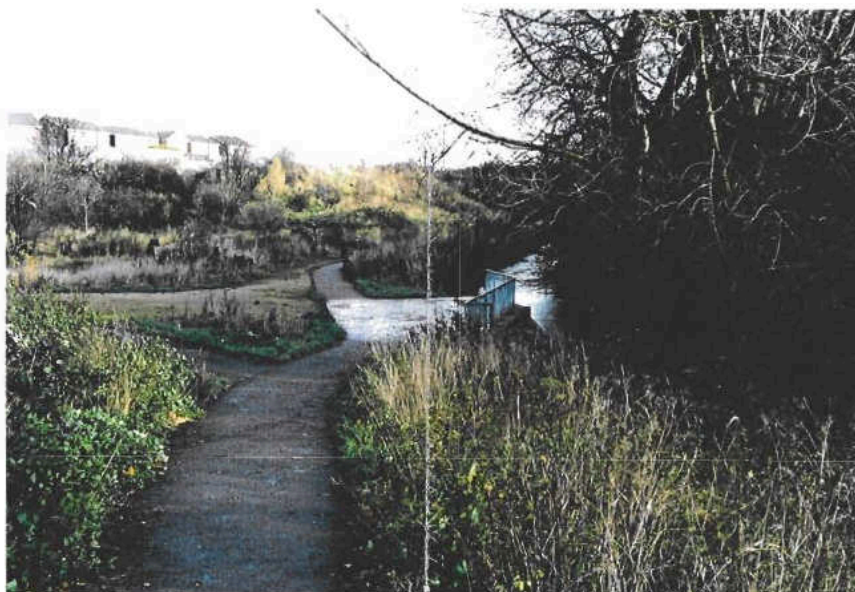
Section 3

‘the character of the area is...fragmented and varied, but generally of an enclosed semi-natural or part derelict appearance’

‘semi-natural vegetation provides a valuable green edge screening out unsightly buildings’

‘the right bank includes a confined corridor with mature trees adjacent to allotments’

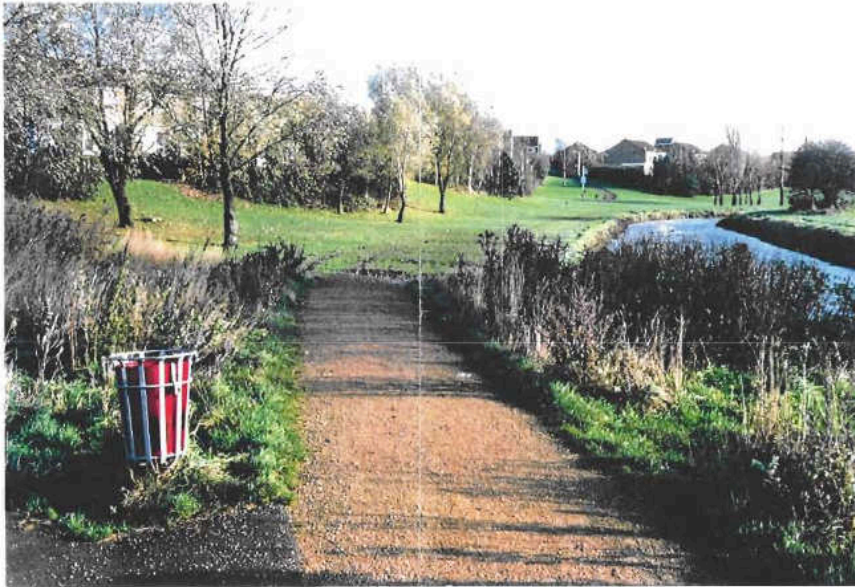
Section 4

‘the corridor consists of a complex series of spaces which appear as fragment units containing both semi-natural and tamed areas’

‘the character adjacent to the housing area changes to managed parkland with mown grass and groups of trees’

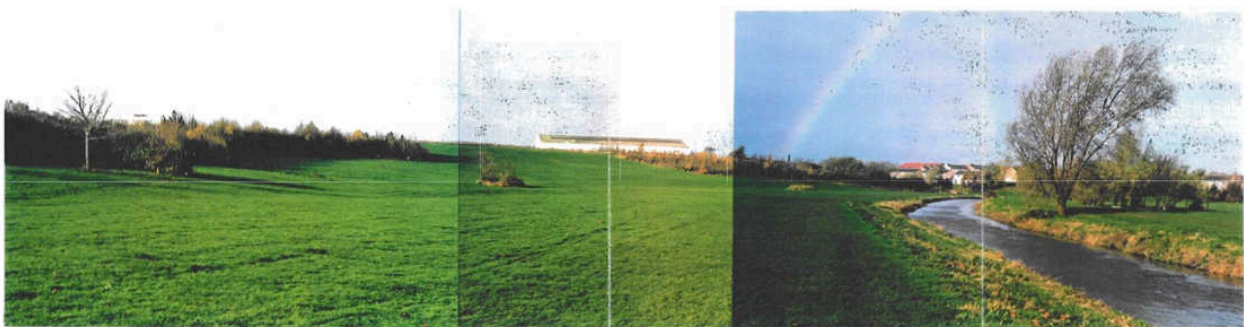
Section 5

‘it has a medium scale open space which has a unified feel’

‘the character is one of managed parkland on both sides of the river with few features’

‘industrial buildings dominate the skyline on the left bank’

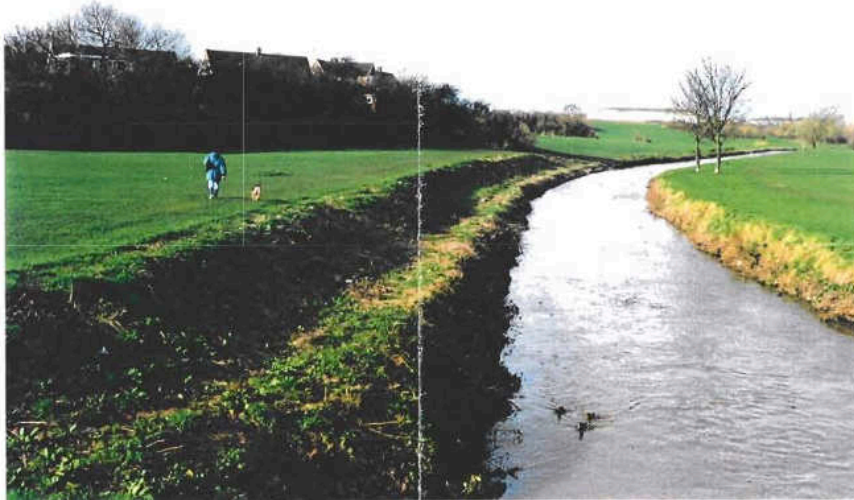
Section 6

‘the area is managed parkland with a fairly unified appearance’

‘traffic noise on Haughton Road has a major impact on the area’

‘the river channel has been subject to various works including an unattractive terrace built in the 1970s as part of flood defence measures’

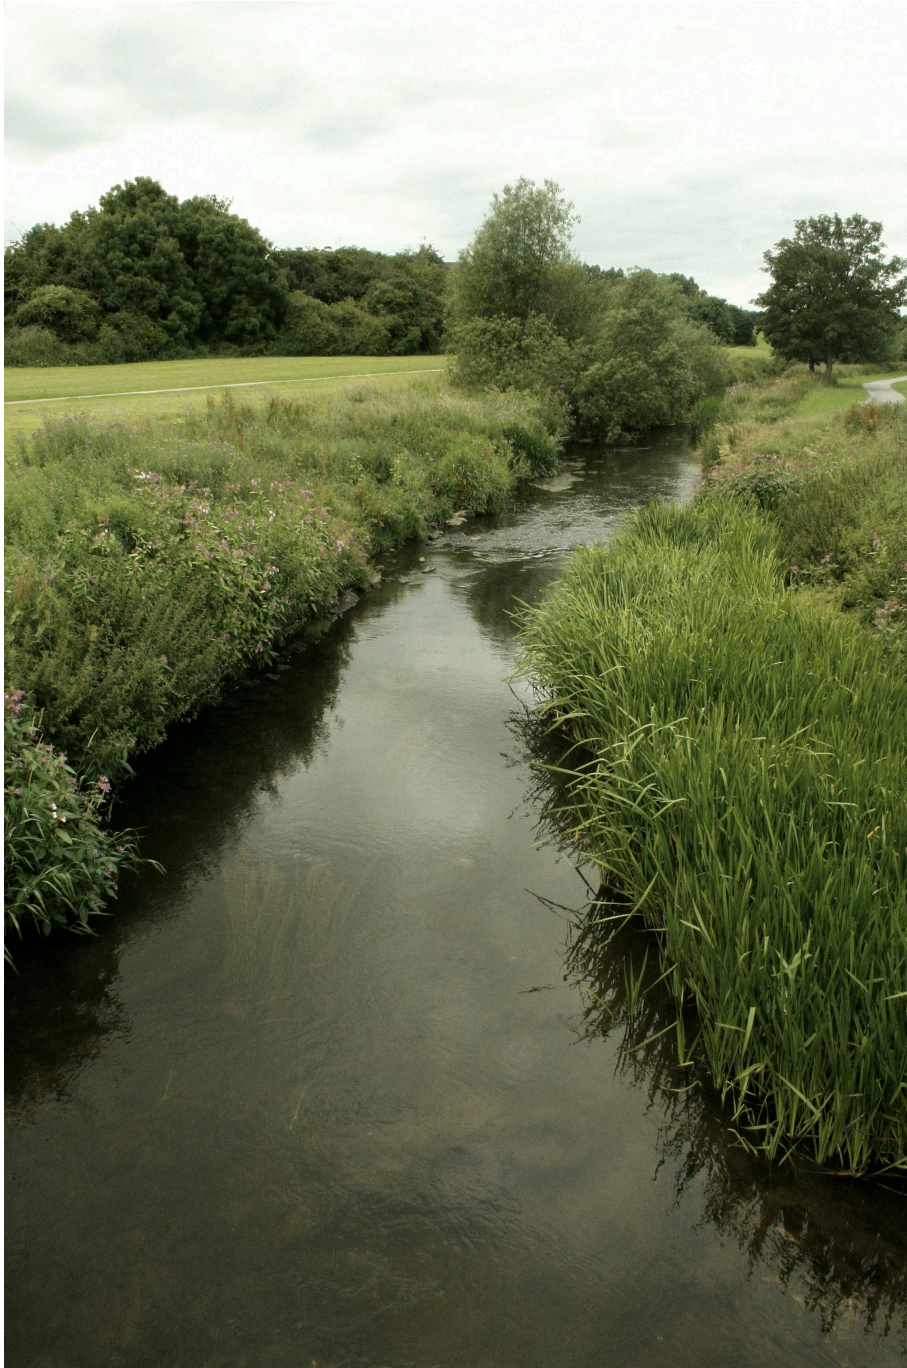
Figure 2. A view of the restored River Skerne. Note the designed aquatic ledge within the channel in the foreground on the right, a self-rooted willow downstream (likely derived from a willow revetment), and the general re-shaping and planting of the channel as compared to the pre-restoration image of section 6 in Figure 1(f) (Photograph by author).

As with the meanders, we see here an interesting interplay between technique design and visual aesthetics. As the visible materials used are natural (the mesh nylon is concealed by the living willow), these interventions at once obscure their artifactual qualities. Thus, along the river, soft engineering does not merely ‘soften the edges’ of hard engineering but rather dissolves the very notion of an engineered river. It also results in the visual integration of discrete structural interventions – meanders, revetments – into a seamless and coherent naturalistic whole. To the

uninformed eye, the meanders and revetments are read as integrated within the channel system, not as a series of discrete restoration techniques (see Figure 2).

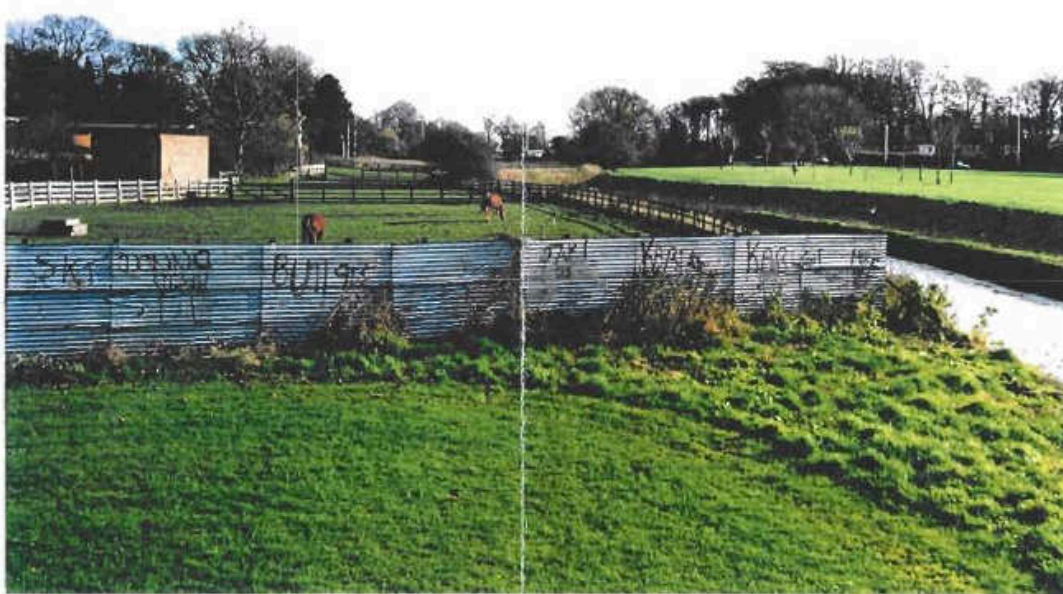
Figure 3. A metal fence at the perimeter of the site before restoration works (3(a)), and after when concealed with hawthorns, elder and dog rose (3(b)). (3(a) copyright the River Restoration Centre, reproduced with kind permission from the River Restoration Centre; 3(b) photograph by author).

Multi-sensory framing through design also encompasses attempts to screen certain visual and sonic aesthetic qualities of the pre-restored landscape. Metal fences have been concealed with hawthorns, elder and dog rose (compare Figure 3(a) with Figure 3(b)), and graffitied walls with ivy; trees have been strategically planted to visually and sonically screen an industrial site to the south of the river; and a flat expanse of clay that was “bare and horrid” (Interviewee 2, September 2009) has been landscaped with grass, creating a smoothly graded incline that peaks at the northernmost section of the site. Collectively, this creates a strong visual and sonic boundary that demarcates the restoration site from adjacent landscapes; in landscape design terminology, this is the production of a “spatial edge” that: “...encloses space, terminates sight line, and defines viewshed” (Motloch, 2000, p. 190).

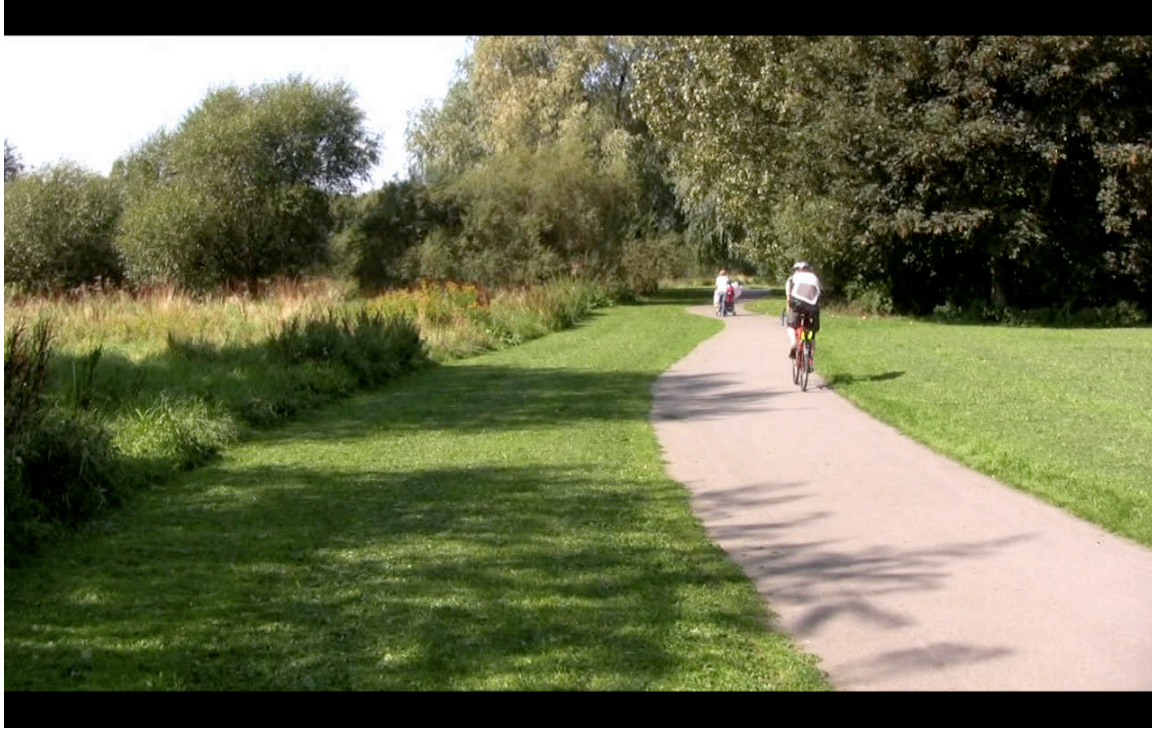
Figure 4. Bitumen cycle and walking path tracing the contours of the new river channel meanders (Photograph by author).

Finally, one concrete walking path to the south and one bitumen cycle and walking path to the north have been laid, which both trace and thus visually accentuate the contours of the new river meanders (Figure 4). Both also allow for comfortable, smooth mobility along the river’s edge, and are suitable for pushchairs and wheelchair users. The concrete path’s buff colour was “chosen to blend with the surroundings once weathered”, and “resting/passing areas were placed approximately every 100m in positions affording interesting views of the site” (RRC, 2002, 8.3). A new footbridge has also been installed to create a circular walk between it and the existing footbridge to the east of the site.

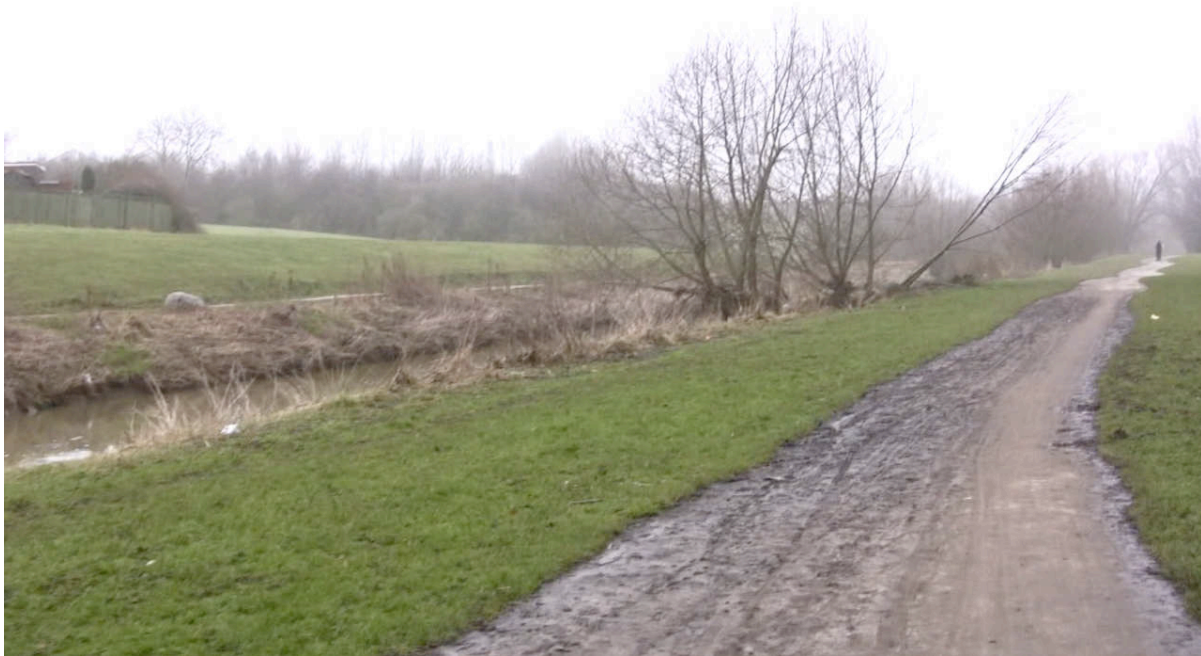
Figure 5. Bankside and river channel after winter cutback (Photograph by author).

These operations result in their own particular spatio-temporal aesthetic qualities. Near-total cutback of vegetation along the banks in September allows for the meandering river channel to be clearly viewed during the winter, and gives a more ‘open’ visual perspective across the landscape (Figure 5). However, the sheer cut is an example of how “...seasonal landscape elements are poorly catered for in environmental management” (Boyd & Gardiner, 2005, p. 197). During this time, an observer of the landscape is made keenly aware that the river’s vegetation relates to cyclical and predictable human design, while the removal of cut debris intervenes in any aesthetic regard for the full cycle of death and regrowth of vegetation, interrupting a seasonal sense of landscape rhythm (after Motloch, 2000, p. 122).
