THE EFFECT OF CIRCULAR DELAMINATIONS ON THE BUCKLING AND POSTBUCKLING BEHAVIOUR OF GLARE LAMINATES UNDER COMPRESSION

Abstract A series of Glare 4B specimens with and without artificial circular delaminations to represent manufacturing defects or damage after impact (bird strike, tool drop) were tested under compression to examine their buckling and postbuckling behaviour and hence the effect of such defects on performance. Tests were monitored using Digital Image Correlation (DIC) for visualisation of full-field displacements whilst Acoustic Emission (AE) monitoring enabled the detection and location of damage propagation. Results for specimens incorporating delaminations inserted in the first Aluminium/GFRP interface and pristine specimens are presented here. Tests have been modelled using a bi-linear cohesive zone model (CZM) implemented in ABAQUS/Explicit to perform dynamic nonlinear analyses incorporating load eccentricity and geometrical initial imperfection. Good correlation is observed between test results and model predictions.

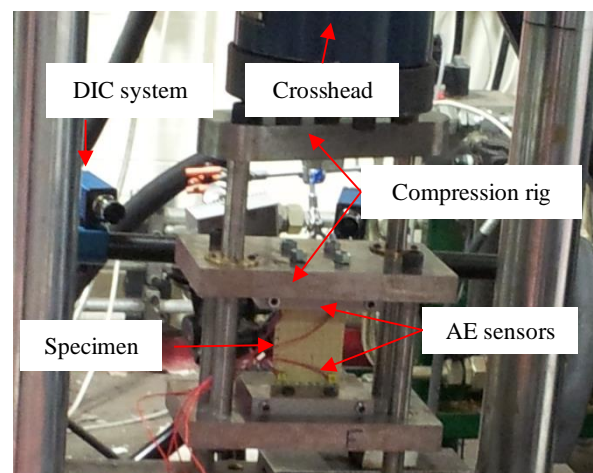
Figure 1. Experimental setup

Experimental work A series of specimens were tested in a Zwick / Roell servo-hydraulic testing machine (maximum force 500 kN) using a specially designed test rig as shown in Figure 1. Specimens measured 140 x 80 mm (unsupported area during testing 100 x 80mm) and incorporated artificial circular delaminations of diameter 50mm created by inserting a circle of PTFE film 10 µm thick into the interface between the first aluminium layer and the first GFRP ply by (Figure 2). They were manufactured by Airbus Germany GmbH from Glare 4B which consists of 3 layers of aluminium alloy 2024-T3 0.4 mm thick and two layers of UD-S2 glass fibre reinforced epoxy (GFRP) prepreg (3 plies with the layup [90°/0°/90°] and a cured ply thickness of 0.133mm) according to the standard for commercial Glare [1]. Each test was monitored using the Limes™ Q-400 stereoscopic Digital Image Correlation (DIC) system with 2 Megapixel cameras with a spatial resolution of (1600x1200) [3] to gain full field displacement data. Four nano 30 Mistras Group™ AE sensors with a frequency response range of 125 – 750 kHz and diameter of 8 mm, positioned as shown in Figure 4 were used to monitor damage. Event locations were calculated using a bespoke location algorithm developed at Cardiff University called 'Delta-T Mapping' [4] which has shown improved source location capability compared to time of arrival (TOA) techniques, especially for anisotropic materials like laminated composites [5].

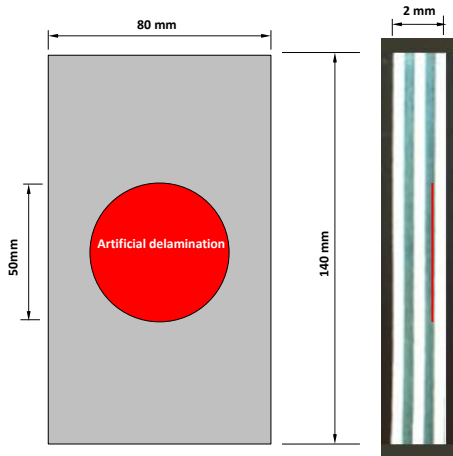
Figure 2. Layout of coupon specimen for Glare 4B-3/2 with a circular delamination

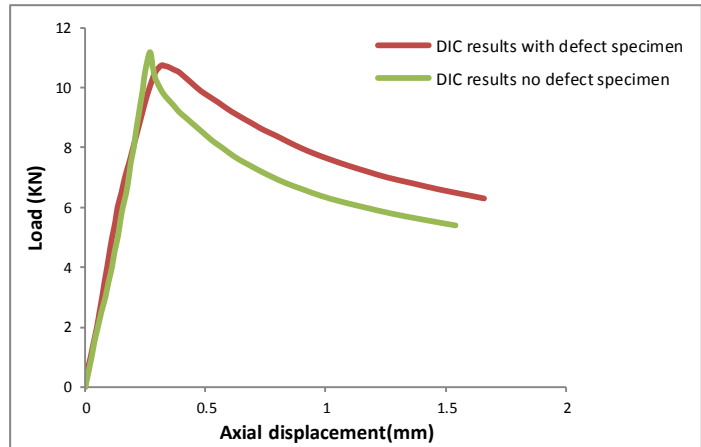
Figure 3. Load-versus displacement for Glare 4B-3/2 specimens with and without delamination

Results and conclusions Figure 3 which plots the experimental load versus displacement of specimens both with and without the shows that its introduction and particularly its location at the point of maximum out of plane displacement during

buckling and size (covering 62.5% of the width) has a significant effect on the buckling and postbuckling behaviour of the specimen. This reduction in properties can be seen to correlate well with the propagation of the delamination as detected by the AE. Figure 4 illustrates the progressive increase in AE events located around the periphery of the delamination as it grows, and in particular around the area where we see the most out of plane displacement (Figure 5). Excellent correlation with the FE model is also demonstrated in Figure 6, which predicts the growth of the delamination around its periphery as well as matrix cracking along the horizontal centreline where the highest curvature is seen. Comparison of the load versus displacement behaviour predicted by the model also shows very good correlation with experimental results showing its suitability in assessing the effects of this type of delamination damage.

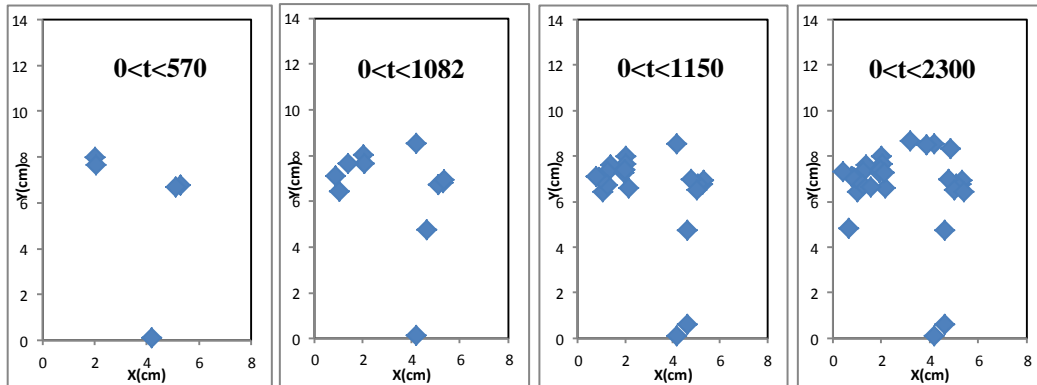
Figure 5. Location of AE events (cumulative)

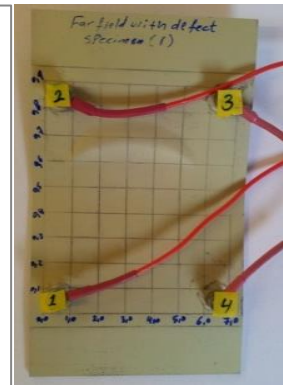
Figure 4. Damage in Glare 4B-3/2 specimen with defect

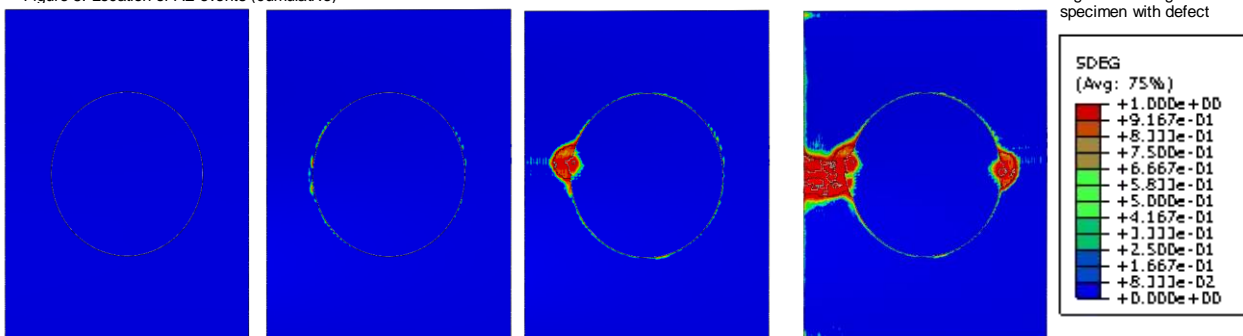
Figure 6. FE model interface damage

FE model A 3D cohesive zone model (CZM) was implemented to simulate damage in the interfaces. The geometry and thickness of each layer were extracted from detailed scans of real specimens with each layer meshed using linear continuum (C3D8R) elements with one element through the thickness. The interfaces between each layer were meshed using cohesive (COH3D8) elements. The laminates were then assembled and material properties were assigned accordingly based on a comprehensive literature review of the mechanical properties for the Glare material constituents. Geometric imperfections and load eccentricity were included [6]. Artificial delaminations were introduced via a reduction in cohesive properties along the interfaces covered by the PTFE strip.
