Localisation and Identification of Matrix Cracking and Delamination in a Carbon Fibre Panel under Fatigue Loading using Acoustic Emission

Abstract

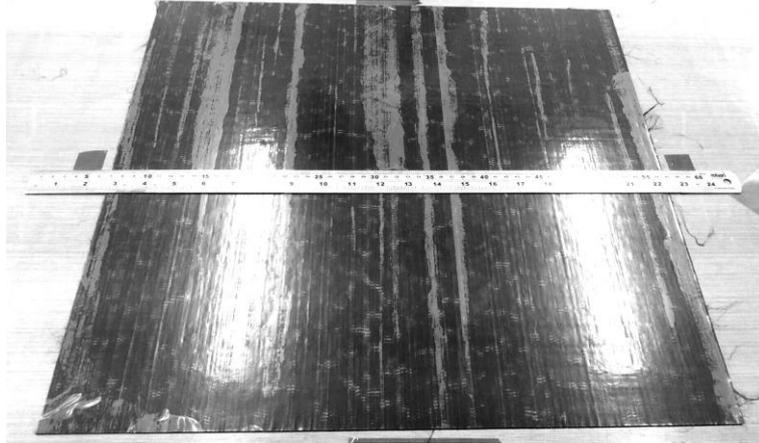
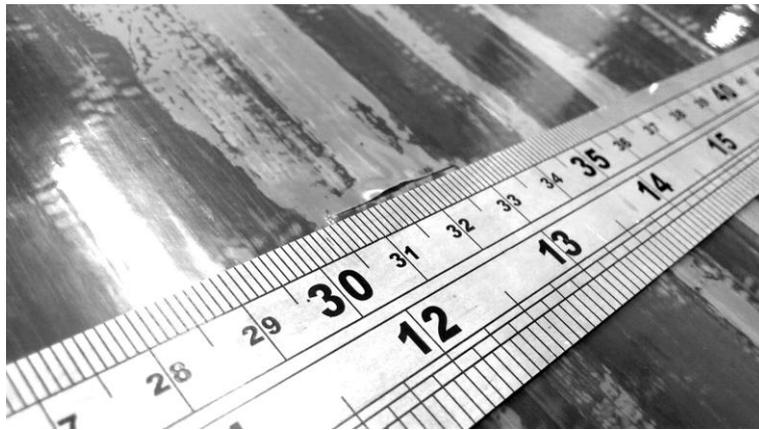
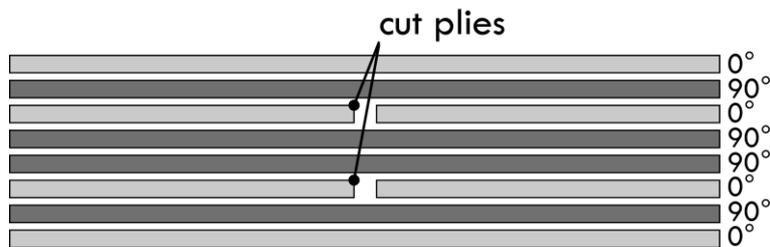
Figure 1: CFRP panel during layup of the inner plies

To promote matrix cracking in the innermost 0° layers (3rd and 6th) a 25mm crack was introduced by cutting the fibres with a knife. Particular attention was paid when manufacturing the final lay-up to ensure that the two cracked layers were aligned (Figure 1). This would ensure matrix cracks are more likely to happen in this area as these plies are no longer supported by longitudinal fibres in the direct loading path.

(a) the entire panel

(b) detail of the cut

(c) cut plies schematic

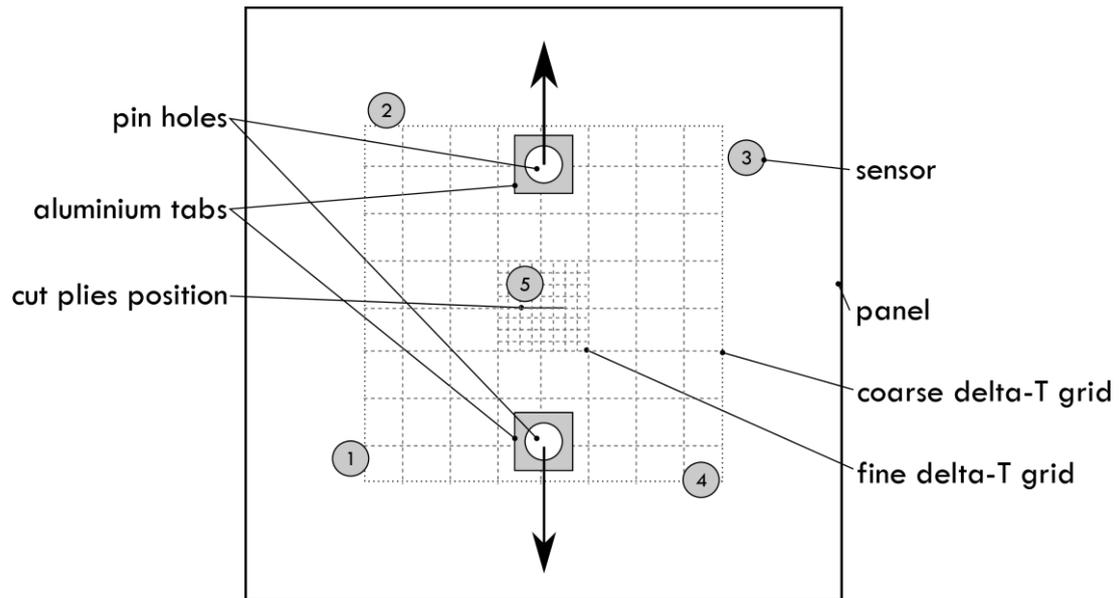
Figure 2: Artificial crack panel after manufacturing

To allow the panel to be loaded in tension, two holes were drilled and reinforced with aluminium square tabs. This prevented crushing of the composite under tensile loading.

The tabs were bonded before cutting the holes with araldite glue; the holes were then drilled through both aluminium and the material. Another C-scan was then performed to compare with the original scan to make sure that it was not damaged during this process. The final panel geometry is shown in Figure 2.

The panel was then prepared for the Delta-T location calibration. A square grid was drawn with two resolutions (Figure 2): the bigger one, 300mm×300mm wide, featured a 50mm spacing; in the central region a finer grid was drawn, with a 10mm spacing and a 100mm×100mm size. The smaller grid is used to get a more accurate location of damage in the cut plies region.

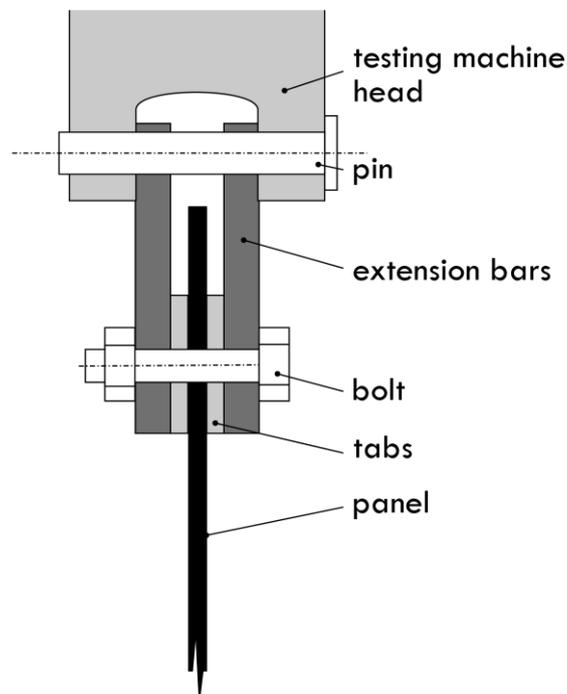
Figure 3: panel fitting in the tensile machine

A schematic drawing of the specimen in the tensile machine is shown in Figure 3.

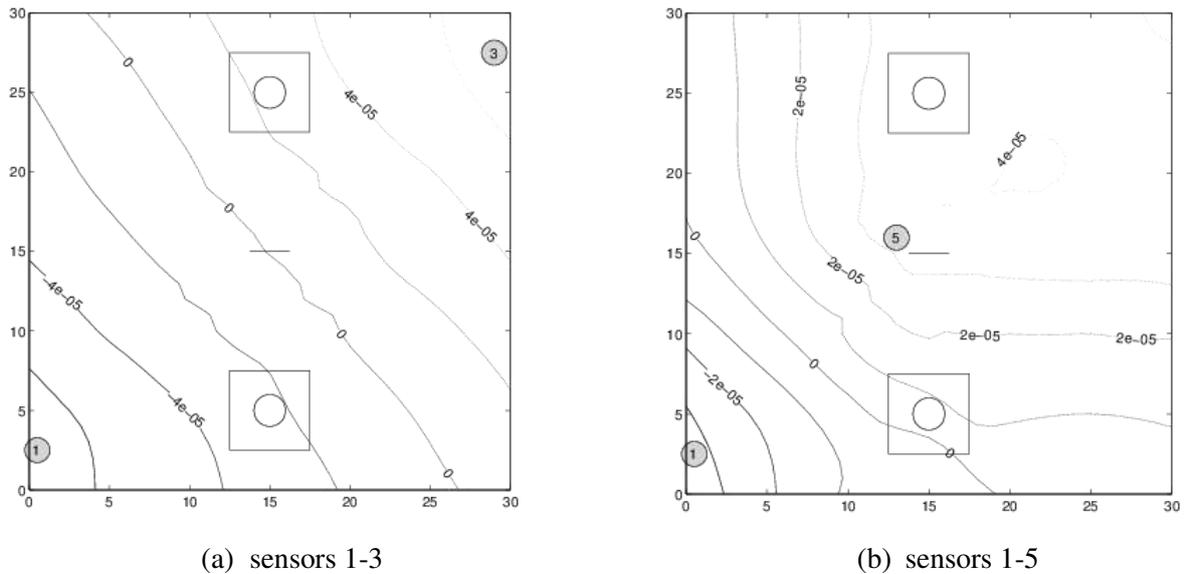
Figure 4: Examples of Delta-T calibration maps

Two examples of the Delta-T maps are shown in Figure 4 (ten are created in total, one for each sensor pair). It is interesting to observe how the Delta-T technique allows for compensation of the disturbances of wave propagation around the tabs and local anisotropies in the wave velocity due to the woven material.

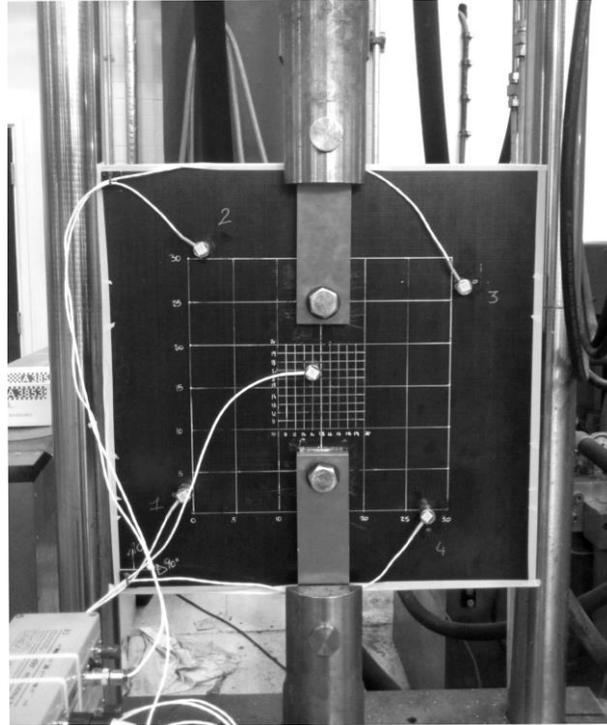
Figure 5: Panel with sensors and fitted in the testing machine

After Delta-T calibration, the panel was fitted into the load test machine. A pin, running through each extension bar hole, connected the panel to the load test machine. The panel was then bolted into the extension bars (Figures 3 and 5). The bolts were tightened before starting the test, thus using friction to improve the load transfer between the machine and the panel. Particular care was used in making sure that the extension bars were vertical at almost-zero load. The panel fitted in the testing machine can be seen in Figure 5.

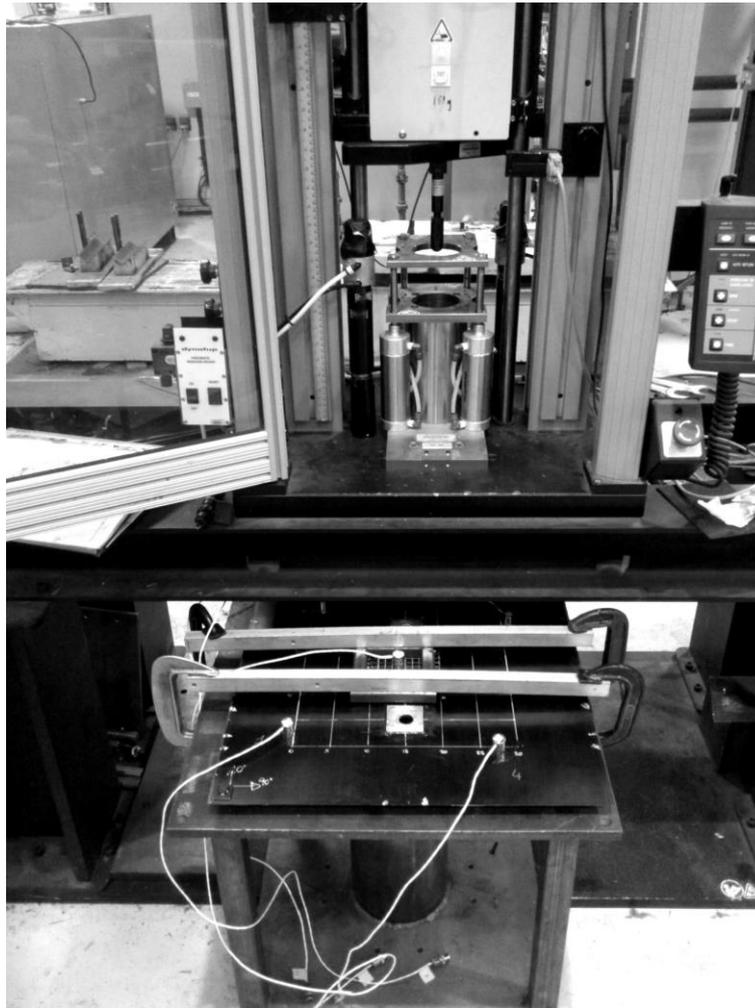
Figure 6: Impact machine and panel fitting

After a sufficient number of AE signals from the artificial crack area were collected (to allow source characterisation), the panel was then impacted with an Instron Dynatup 9250HV impact machine at an energy of 14J, in a location far from the crack but still within the loading path of the test. The impact machine, with the panel frame fitting, can be seen in Figure 6.

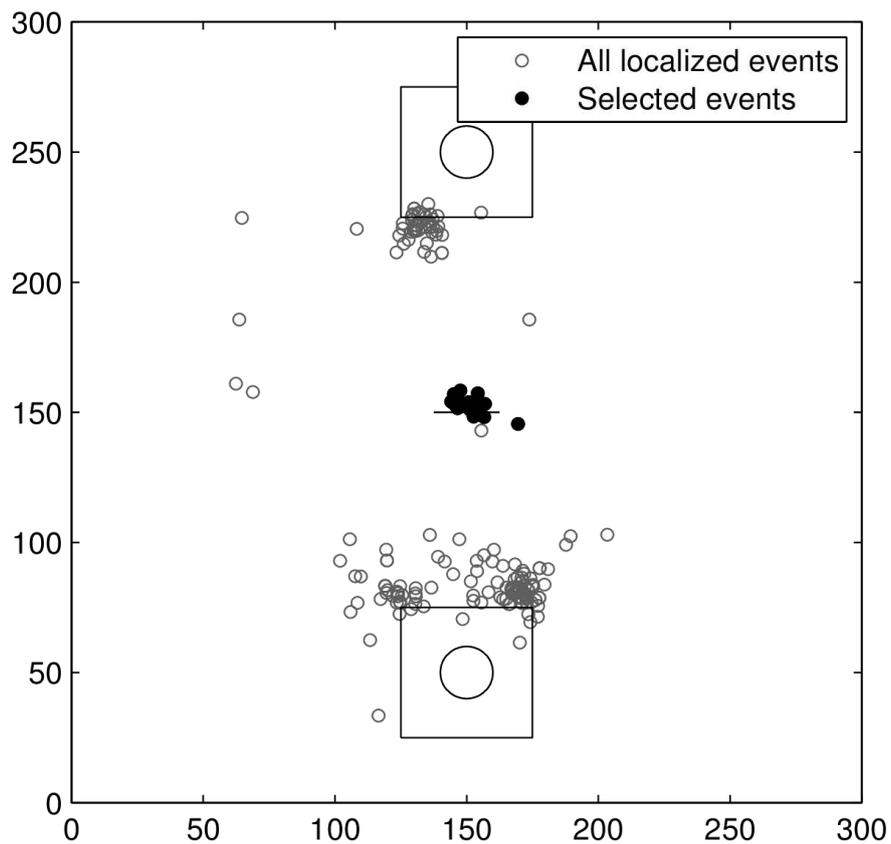
Figure 7: Location of AE events from the crack propagation test.

During the first phase of testing, about 40 AE signals were detected from the crack region, with a good location accuracy (Figure 7). The regions around the bonded tabs also released AE signals, especially at the corners of the aluminium tabs; this was not unexpected since the stress field induced by the loading fixtures are likely to produce a concentration of stresses. Only signals from the crack region were utilised for this analysis as shown in Figure 7.

Also, for classification repeatability purposes, sensor 5 was considered throughout the whole test. Therefore, there are a few signals (as visible in Figure 7) that were located in the region of interest and were not recorded by sensor 5, although they are a small percent (around 2% of the total). A sample of the selected waveforms are shown in Figure 8.

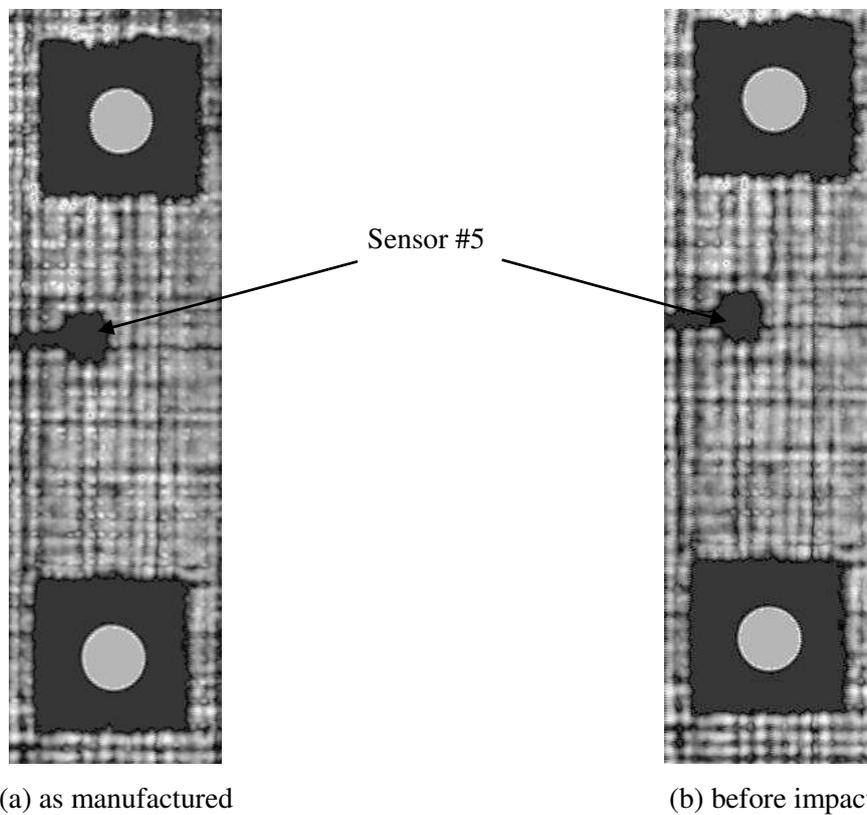
Figure 9: C-scan images of the panel central region during the crack propagation, also showing sensor location

The C-scans at the beginning and after the last batch without impact are shown in Figure 9. The central sensor (number 5) is always visible in the C-scans as a dark spot with its attached cable running to the left.

C-scans confirm that no additional damage has been introduced during the test. No high attenuation (dark) areas are found; this confirms the absence of in-plane discontinuities, like delaminations. The crack region, below the sensor visible in the centre, appears to darken slightly, but no evidence of growth can be observed.

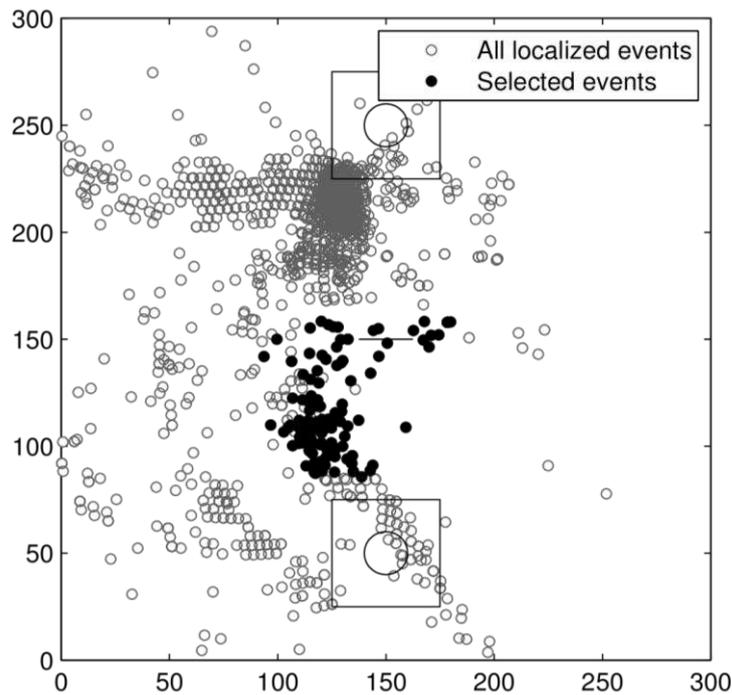
Figure 10: AE events during the selected after impact batch

After the impact, the AE activity of the panel increased significantly. Figure 10 shows AE localised events for the last batch after impact (batch 31). The test was then interrupted since it showed significant sources from the impact region. The figure also shows the selected events from this set.

The location accuracy appears reduced, mainly due to the presence of the impact area which alters wave propagation path, while the undamaged calibration was retained. Nevertheless, it has to be noted that signals from the crack area have decreased in number, and moved towards the crack tips. This is a consequence of the fact that the crack region has reduced its stiffness, the stress field has been modified to increase at the sides of the crack and zones of stress concentration exist around the crack tips. Therefore, those signals may indicate some damage mechanisms happening at or near the crack tip regions. A sample of the signals coming from the delamination region is shown in Figure 11.

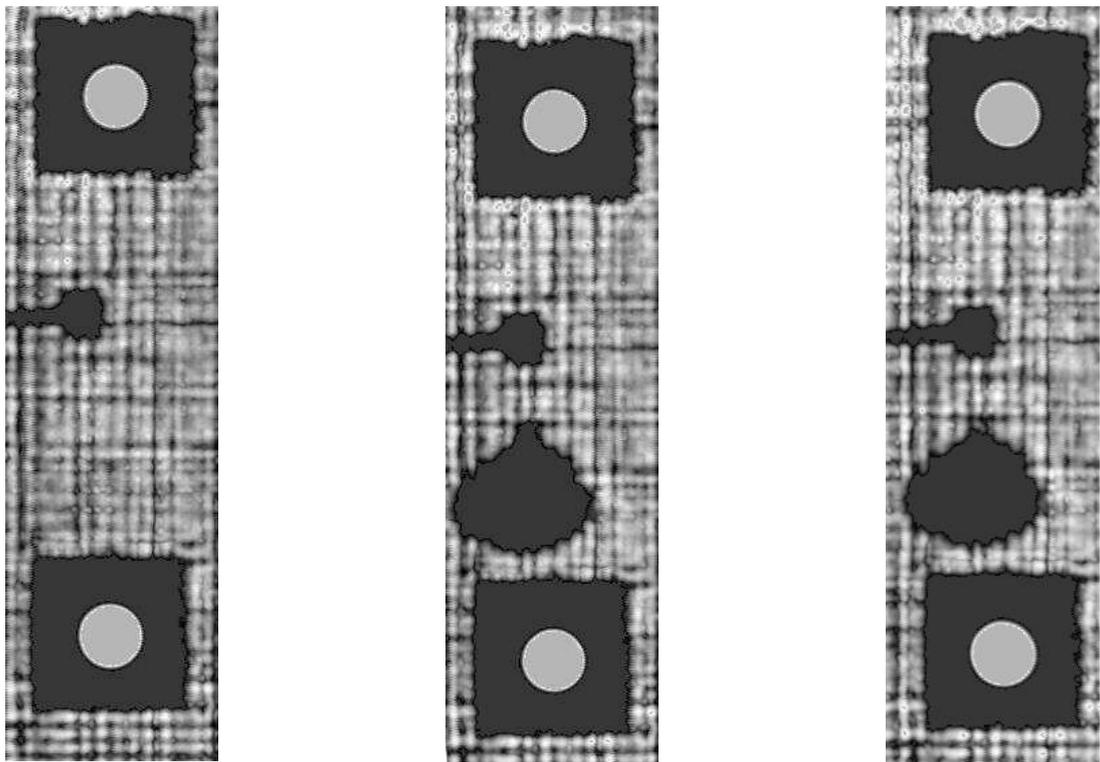
Figure 12: C-scan images of the panel before and after impact

The delamination size after impact was determined by C-scanning the panel again, as visible in Figure 12.

(a) Before impact

(b) After impact

(c) End of the test

A final C-scan after all fatigue testing was completed indicated that the delamination had not grown significantly (Figure 12c).

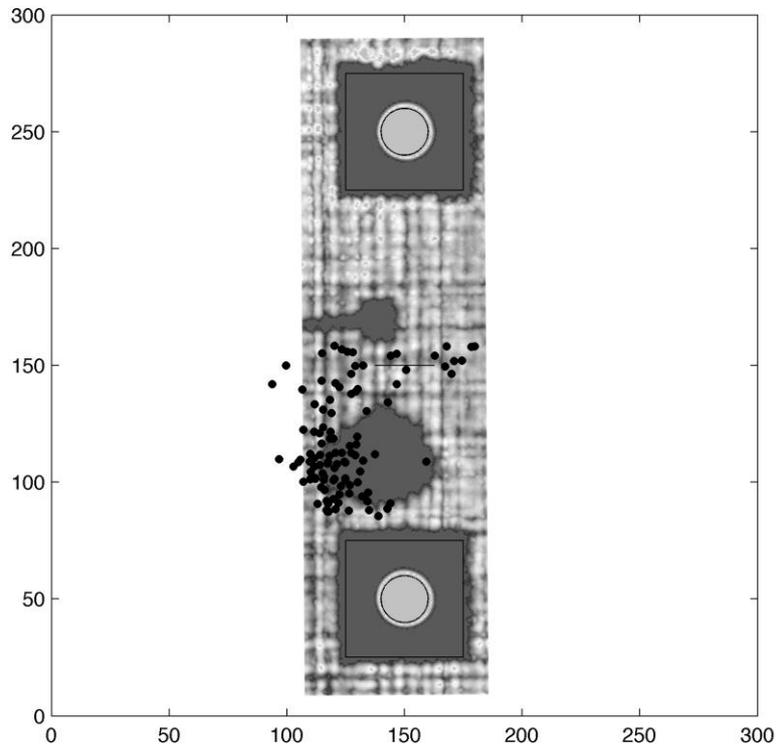
Figure 13: AE selected events superimposed to the C-scan

Superimposing AE data to the C-scan, it is clear that only the left border of the impacted area shows AE activity (Figure 13).

A possible explanation for this, considering that the delamination has not grown, would be that the active areas in the delamination are the ones that experience some type of rubbing or frictional phenomena, or in other words those areas that experience a high stress gradient, due to the particular stress field the panel is exposed to.

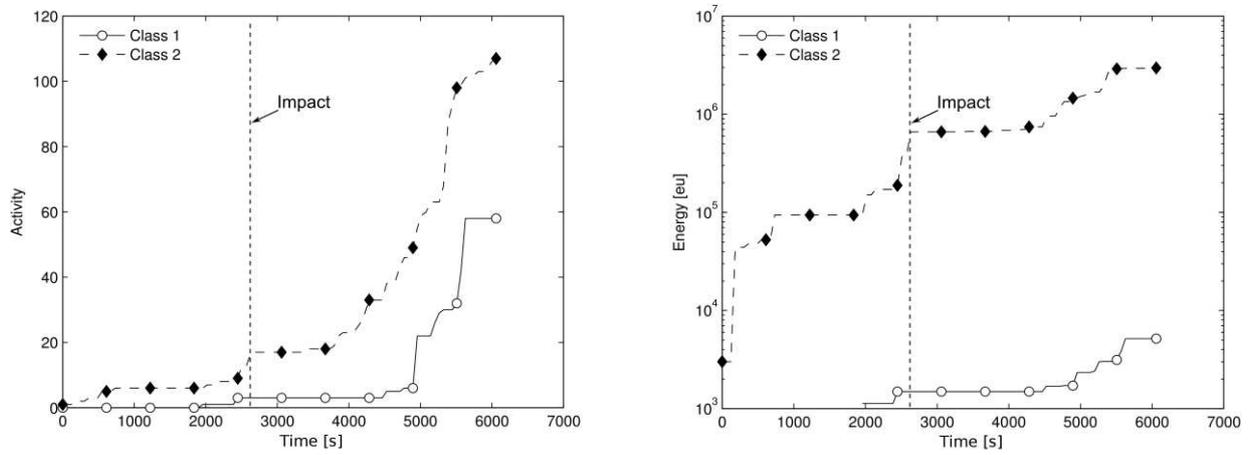
Figure 14: AE activity and energy trends, after classification

Global AE energy and activity trends (Figure 14) show that the first part, before impact (0 to 2646s), is dominated by Class 2, while Class 1 remains almost silent. Class 1 is observed at approximately 4500s, with an increasing trend, which is followed by Class 2.

(a) activity

(b) energy

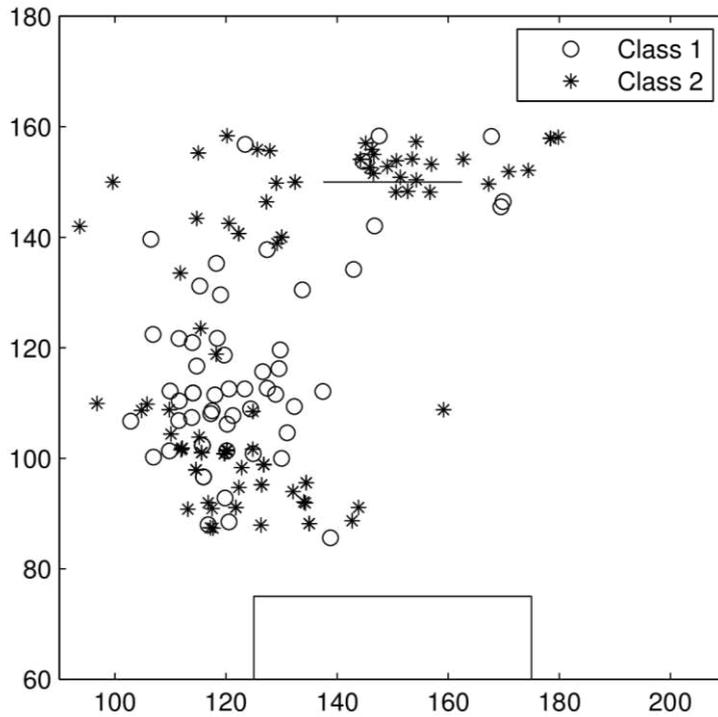
Figure 15: Classified signals in the selected region

All classified localised signals for the two batches considered are shown in detail in Figure 15.

From this preliminary observation, it can be noted that the crack region holds mainly Class 2 signals, while the impacted area shows a mixture of both Classes, with Class 1 being evenly spread and Class 2 concentrating at the bottom boundary.

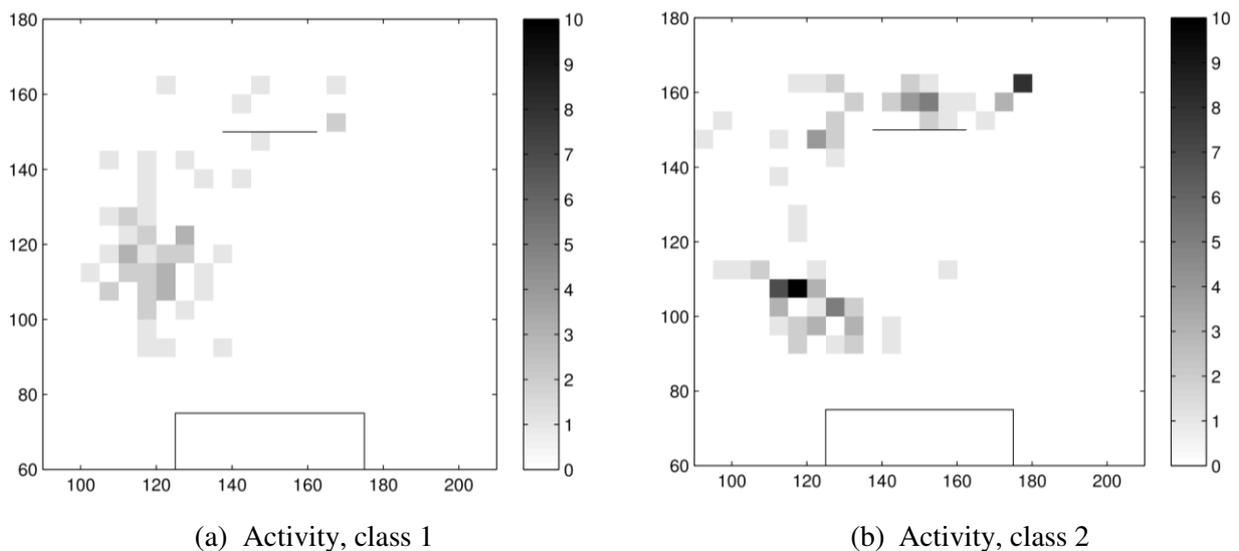
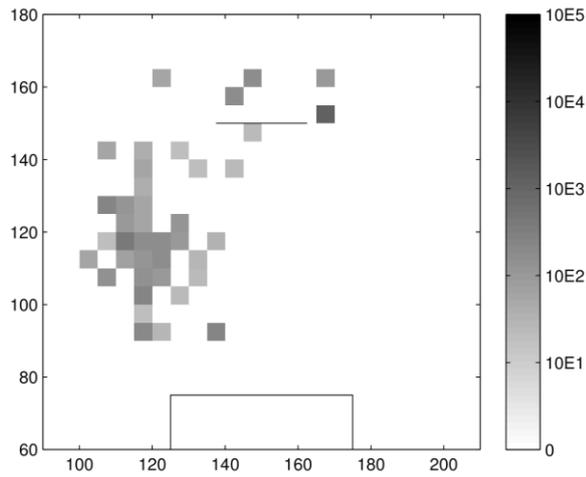
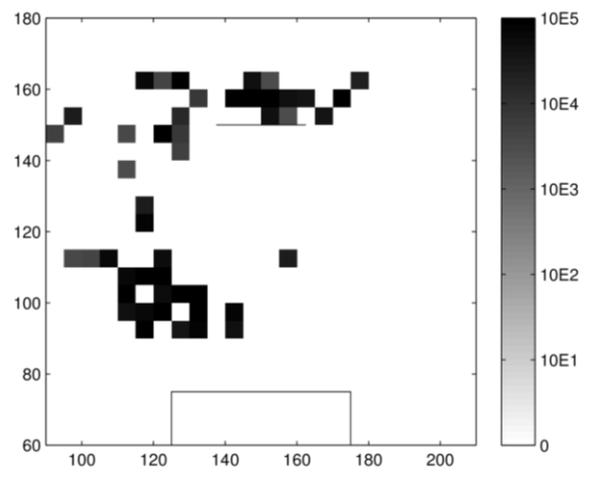
Figure 16: AE energy and activity 2D maps, by class

Energy and activity maps (Figure 16) show that Class 1 has a lower energy than Class 2, and is concentrated, as previously observed, around the impacted area and at the crack tips. Class 2 is concentrated in the middle of the crack and at the tips, and at the bottom boundary of the impacted area.

(a) Activity, class 1

(b) Activity, class 2

(c) Energy, class 1

(d) Energy, class 2

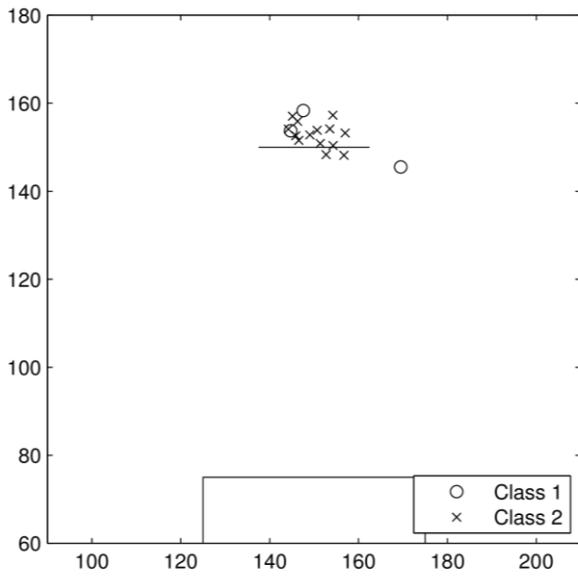
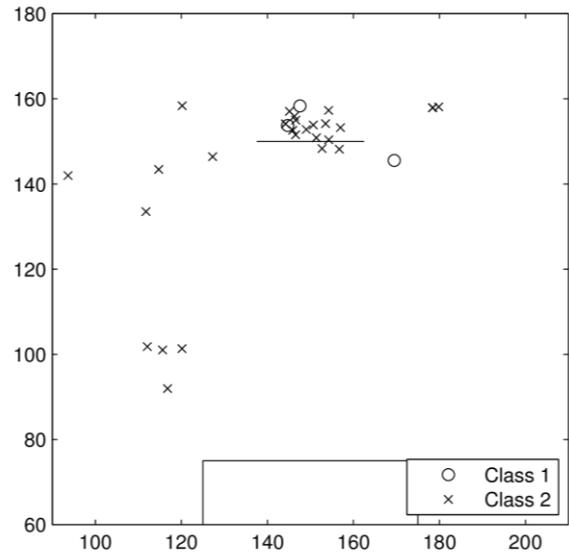
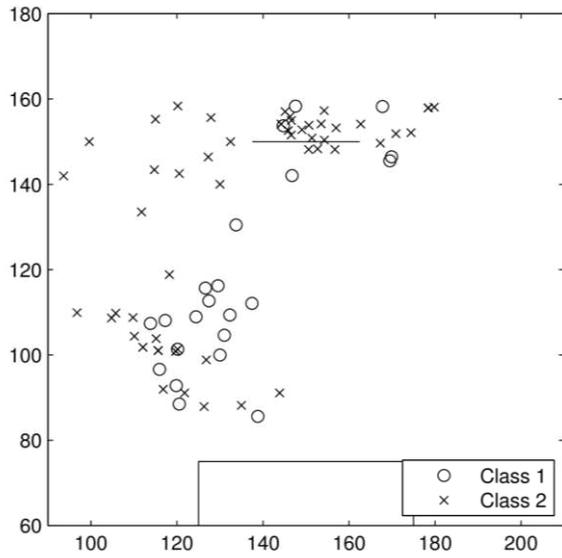
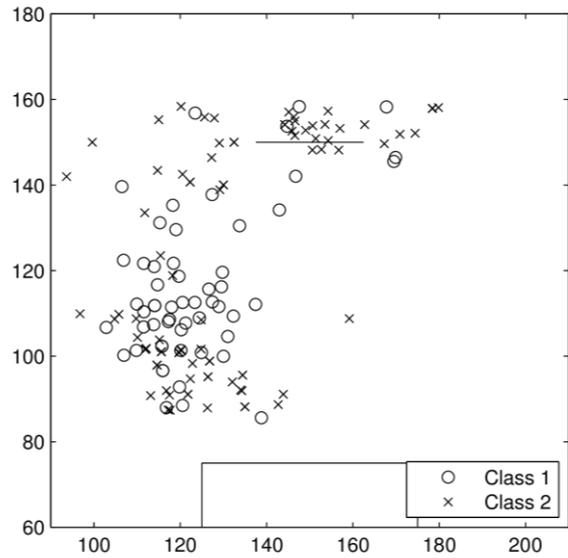
Figure 17: AE events in time, classified

Considering the aforementioned time blocks, the evolution of signals is shown in Figure 17.

(a) t=0 to 2646s

(b) t=0 to 4500s

(c) $t=0$ to 5200s

(d) $t=0$ to end

Here, the signal evolution indicates that, after impact (Figure 17b), a number of Class 2 events appear in the damaged region; then, a mixture of Class 1 and Class 2 signals are emitted at a similar rate.

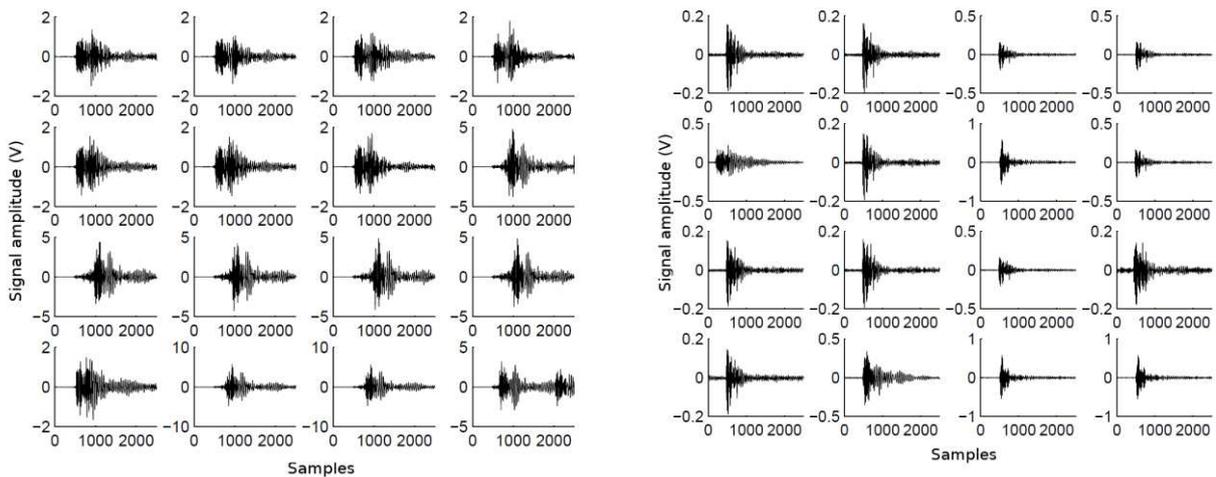
Figure 18: waveforms from the two dataset classes

An example of the waveforms from both classes is shown in Figure 18. Here it is clear that the classification technique is capable of separating two distinct groups of waveform shapes. Also, average parameters for the two classes are reported in Table 3.

(a) Class 1

(b) Class 2

It was also observed that the two classes show repeatable sources, with distinct waveforms and AE parameters. In particular, matrix cracking sources show higher amplitude and with a relatively quicker decay, while delamination sources appear more continuous.
